FULL BUILDING SURVEY

**Lynbrook House
Stocks Lane
Bristol
BS14 7DG**

10 October 2019

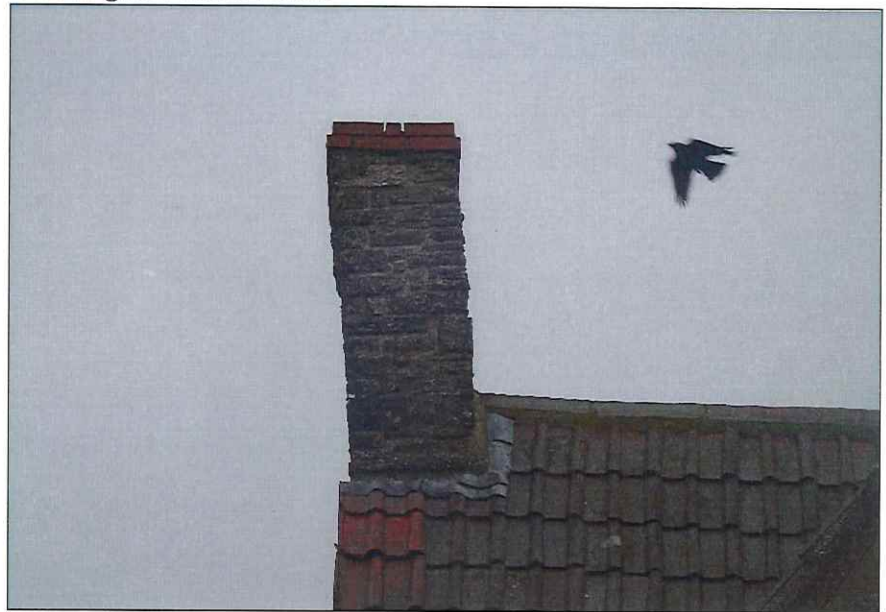
There is evidence of distortion to stacks, perhaps the most noticeable on the front left hand stack which can be seen in adjacent photographs. This is not considered unusual for a building of this age and character although the situation must be carefully monitored. There may well be the requirement for some reconstruction should distortion persist.

Leaning left hand stack

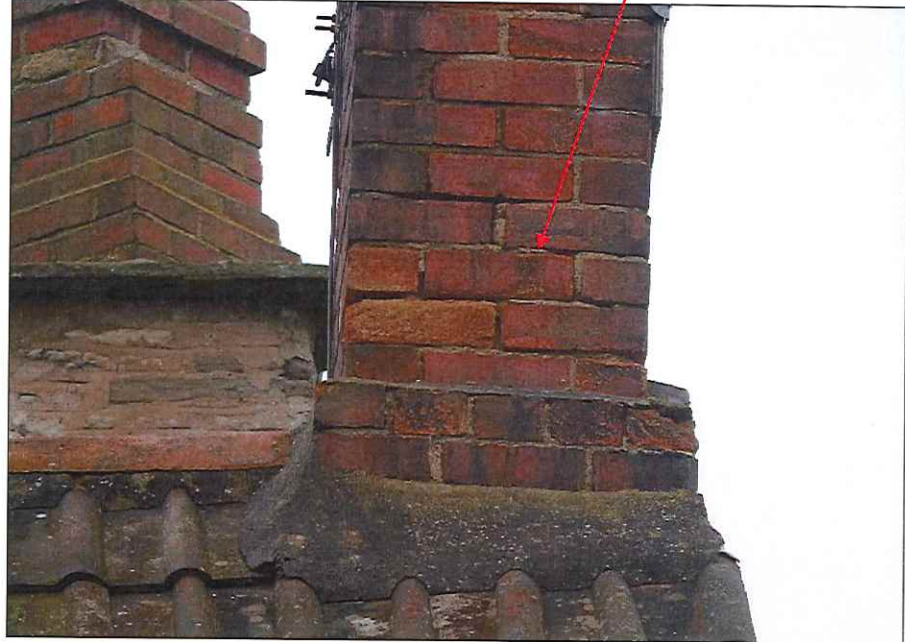
In relation to brickwork, there is evidence of fairly noticeable spalling, particularly to the rear centre stack. Pointing is also poor and repairs are recommended. Cutting out and replacement of any defective bricks together with provision of new cement mortar should be undertaken.

Poor brickwork/pointing – rear centre stack

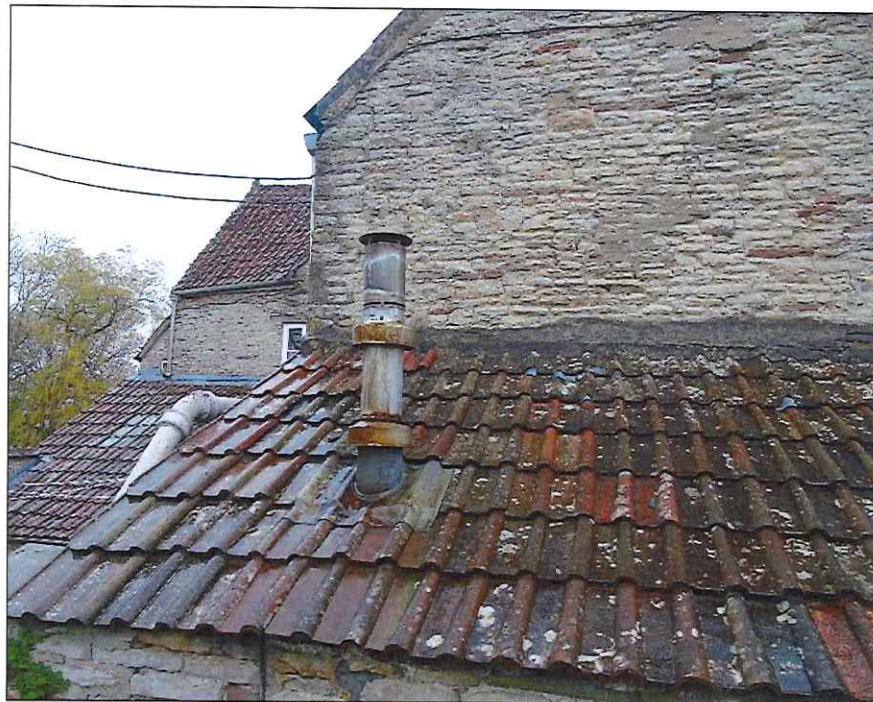
The boiler flue is located on the rear single storey boiler store which also incorporates the ground floor bathroom. The flue itself appeared to be suitably positioned although functional tests were not carried out on the boiler at the time of our inspection. Slight staining is present to the flue which may well deteriorate further with age and this highlights the importance of regular servicing in relation to the boiler itself.

Boiler flue at rear

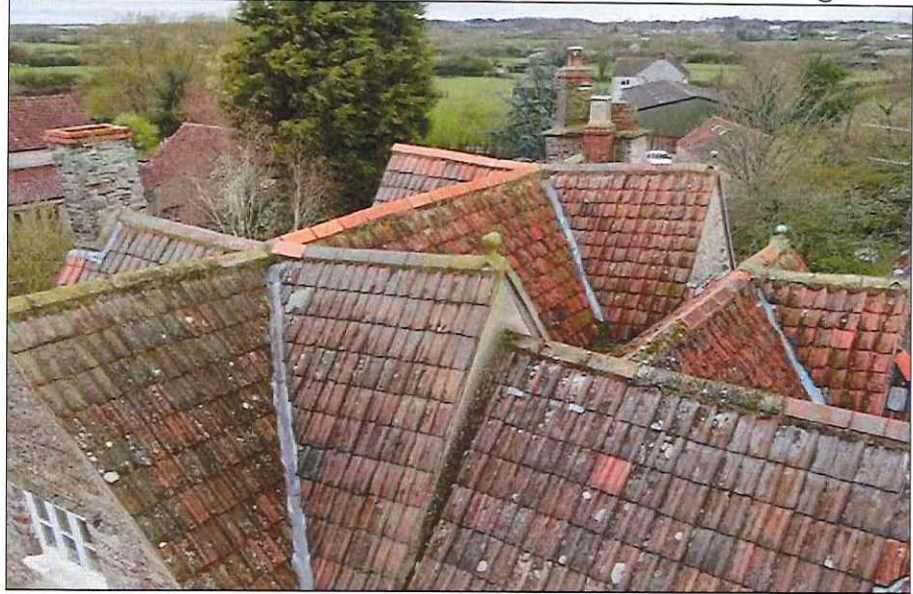
There is a degree of distortion to roof slopes, consistent with many properties of this age and type. Perhaps the most obvious areas are the left hand sections which give the appearance of sloping gently inwards to the central points. There was no indication of any recent deterioration and distortions are within acceptable limits. The roof slopes themselves are laid to appropriate gradients for double Roman and pan tile coverings of this type.

Aerial Photograph General view of roof – note distorted ridges

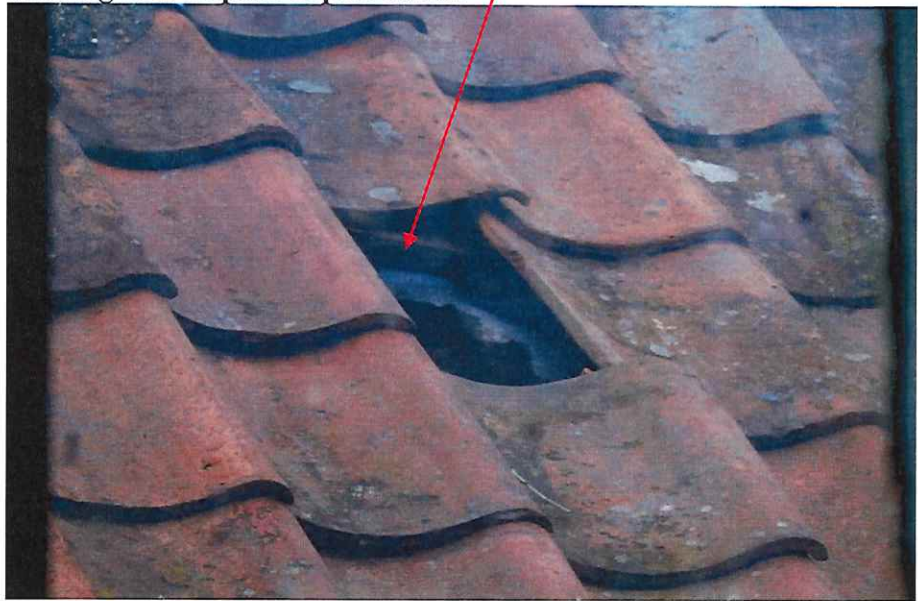
Tiles themselves appeared to be in reasonable condition although there are a number of individually slipped or missing tiles which can be seen in adjacent photographs. Replacement of any defective tiles will be required. At this time, a cautionary examination of any adjacent timbers should be undertaken as leaking over a period of time may have allowed the development of rot.

Missing tiles require replacement

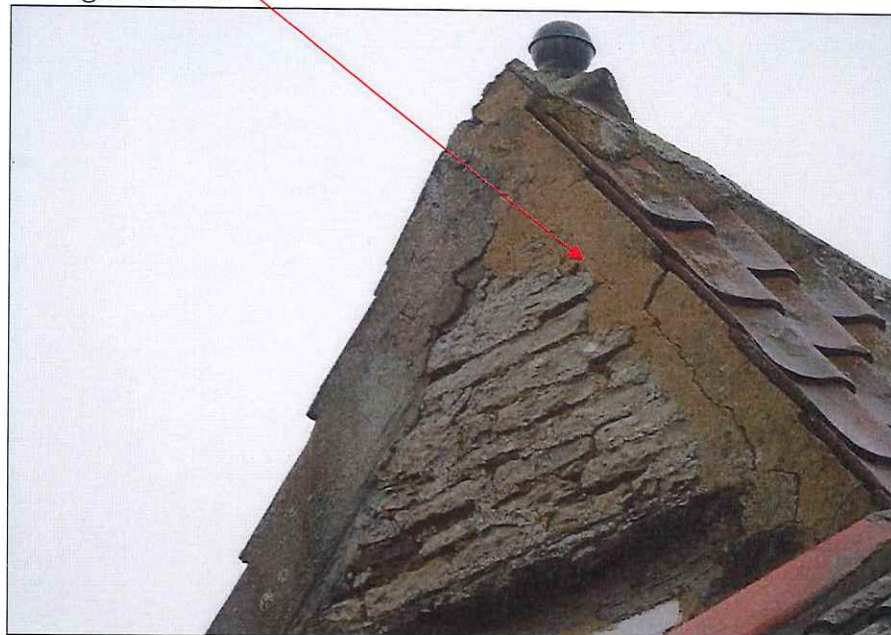
Poor gable detail

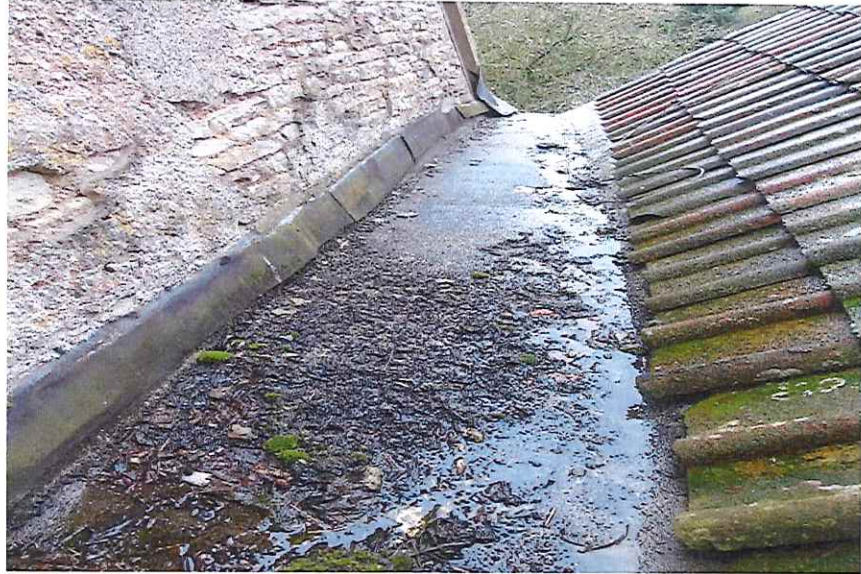
Regular checks on valley linings will be required with any blockage removed as soon as possible. In this instance, there is some slight debris build up in the rear and central valley areas which should be cleared out on a periodic basis to include checking of outlets to ensure that blockage is not developing.

Some debris in valley

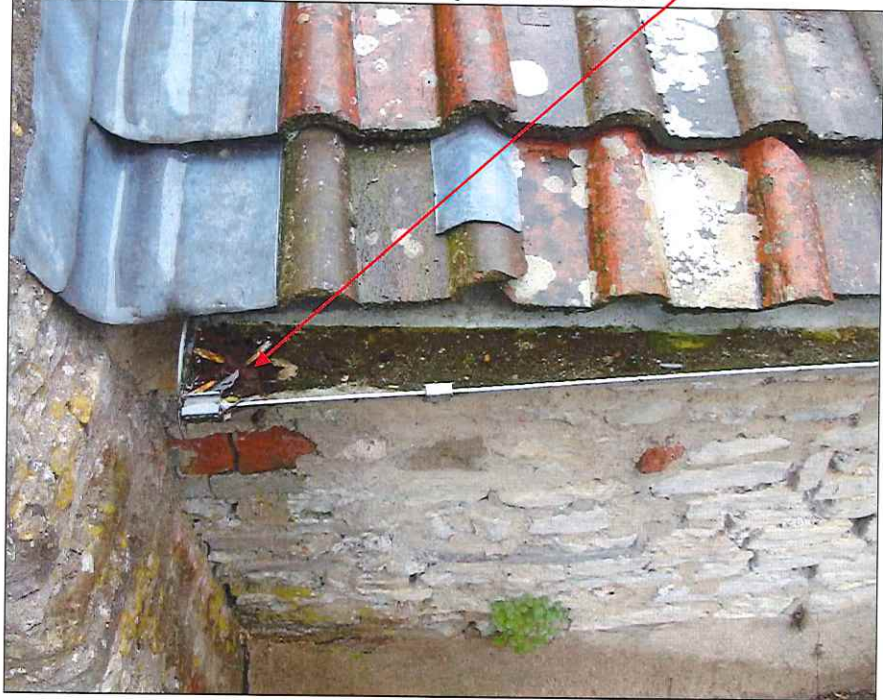
Uneven gutter – rear single storey kitchen roof

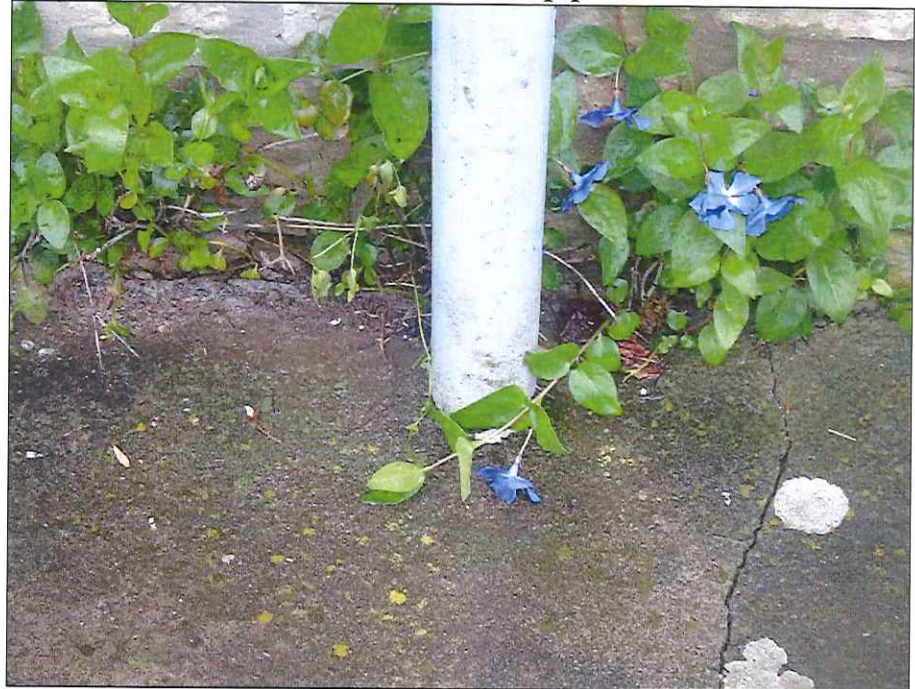
Where the downpipes discharge directly into the underground drainage system they may be more prone to blockage from debris entering the system at eaves level. Ideally, intermediate gulleys or grids should be incorporated where not already provided.

No gulleys at base of a number of downpipes

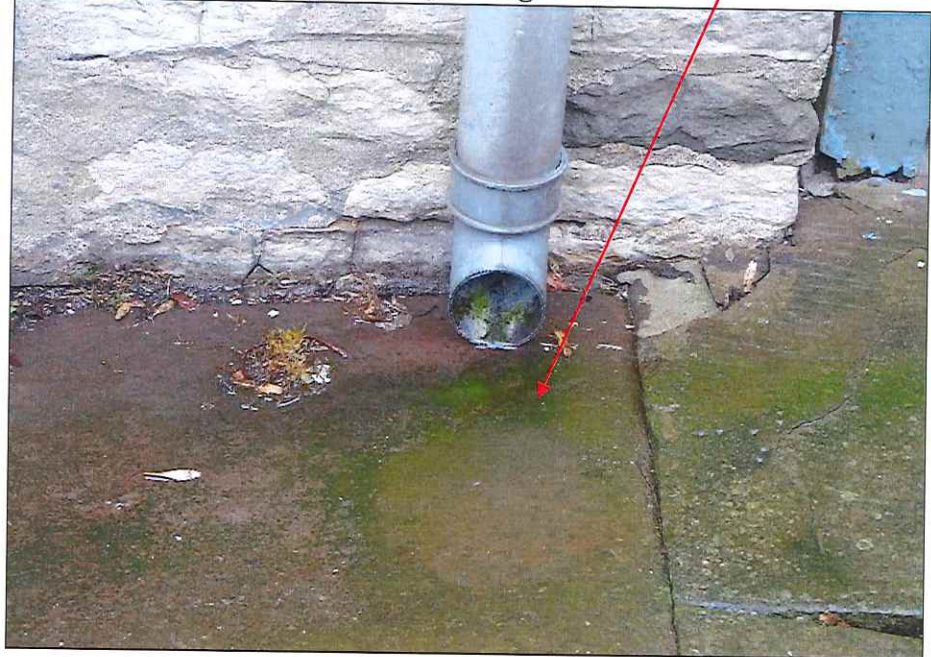
A number of downpipes discharge directly onto the adjacent ground. These should ideally be connected to underground drains or soakaways.

Downpipes discharging directly onto ground

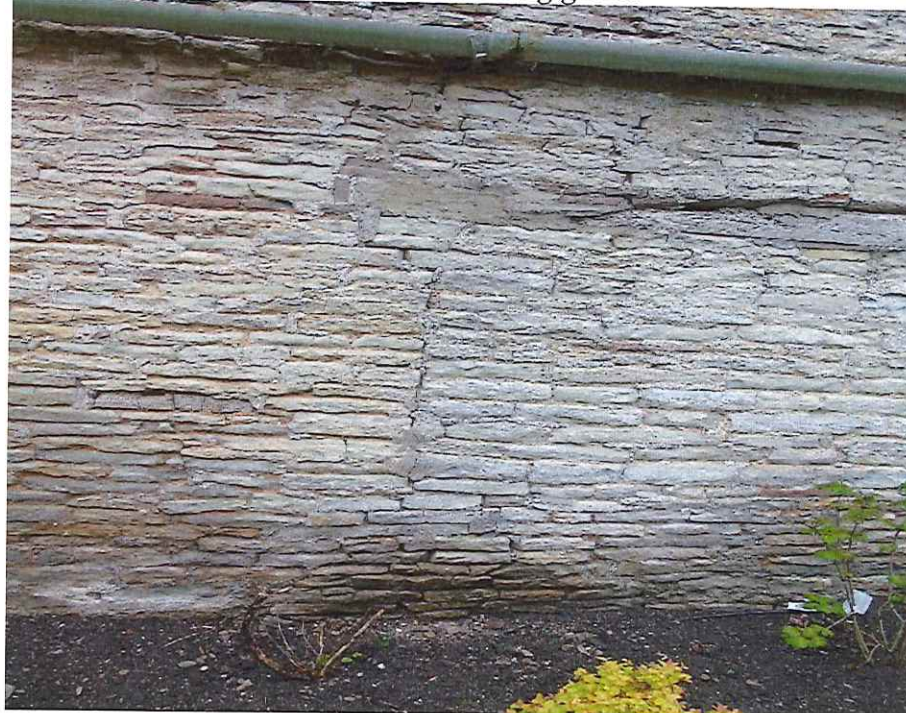
There is a low level gutter arrangement at the rear which is highlighted in the adjacent photographs. This is leaking, staining stonework on the lower parts of the wall which is clearly inappropriate. Sealing at joints is required or, alternatively, replacement with a modern closer fitting gutter.

Stains on lower rear wall due to leaking gutter

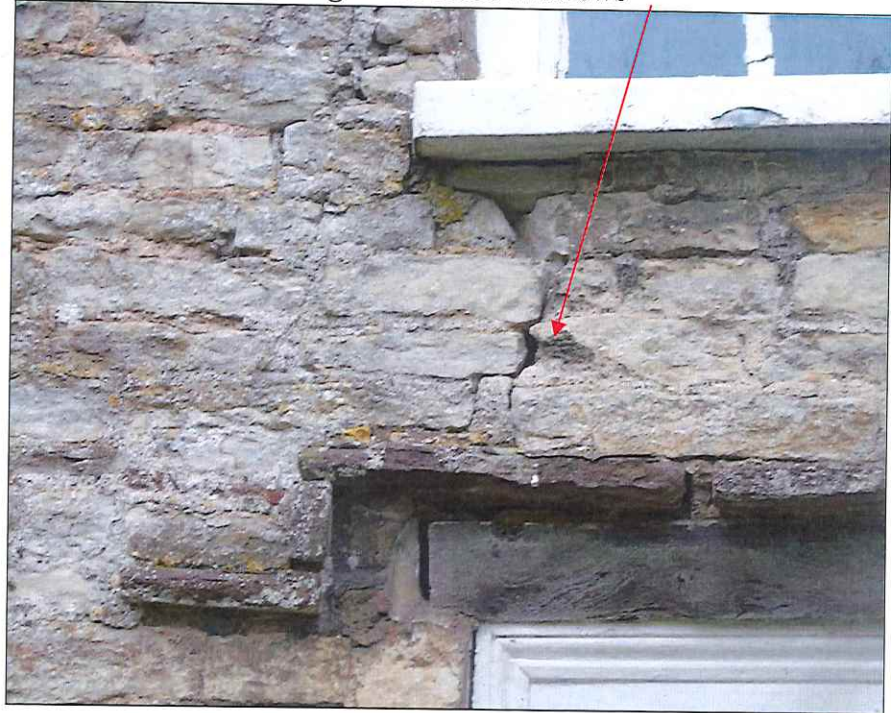
Cracks/distortion over ground floor windows

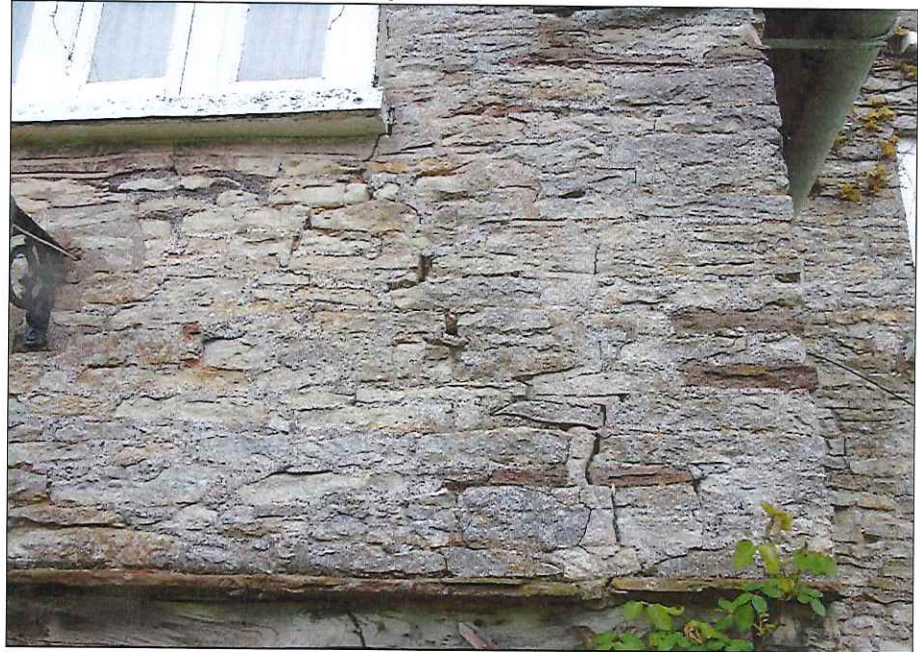
There is a fair amount of external cracking affecting the building together with general deterioration to the pointing. Cracks and areas of movement will be discussed in later sections of the report. In relation to the pointing, it is clear that raking out and repointing together with stitching of cracks will now be required. This should be done in conjunction with checking and replacement of timber lintels, many of which are affected by wood boring beetle infestation and early signs of rot. The compression following wood boring beetle infestation is likely to be responsible for localised movement and this is therefore an important repair.

Repointing required to many areas

In relation to repointing, we do suggest that you consult with a specialist firm, preferably one familiar with listed buildings to ensure that appropriate lime mortar or similar is added in a way that is sympathetic to the building given its listed status.

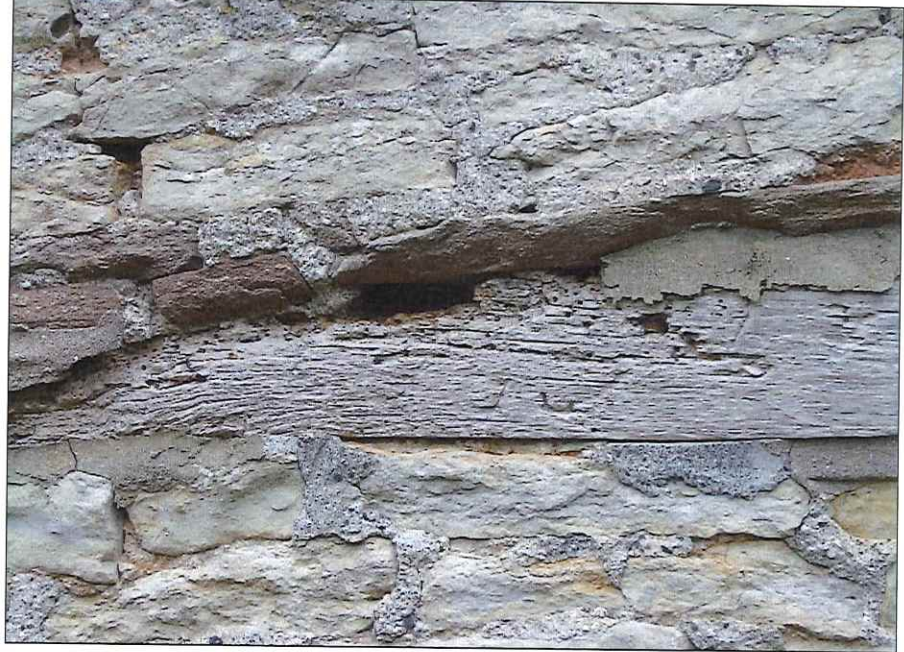
Examples of deterioration to lintels can be found on most elevations with perhaps the most severe to be seen on the top floor part of the right hand elevation and parts of the front.

Wood boring beetle infestation – rear lintel ground floor

Action: Obtain estimates for repointing and repair/replacement of defective timber lintels.

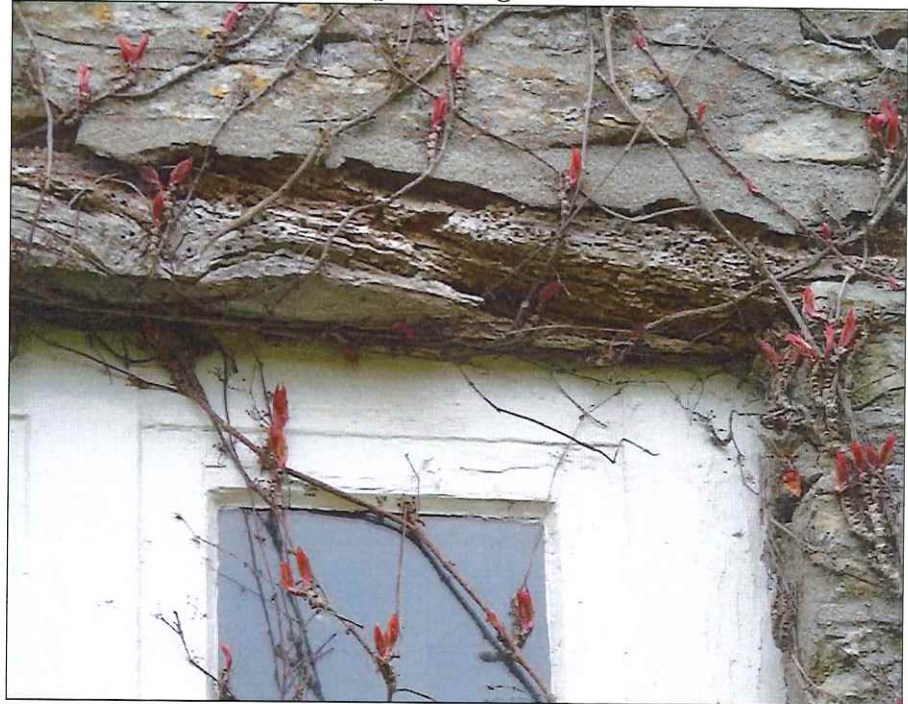
Severely infested lintel – top floor right hand flank wall

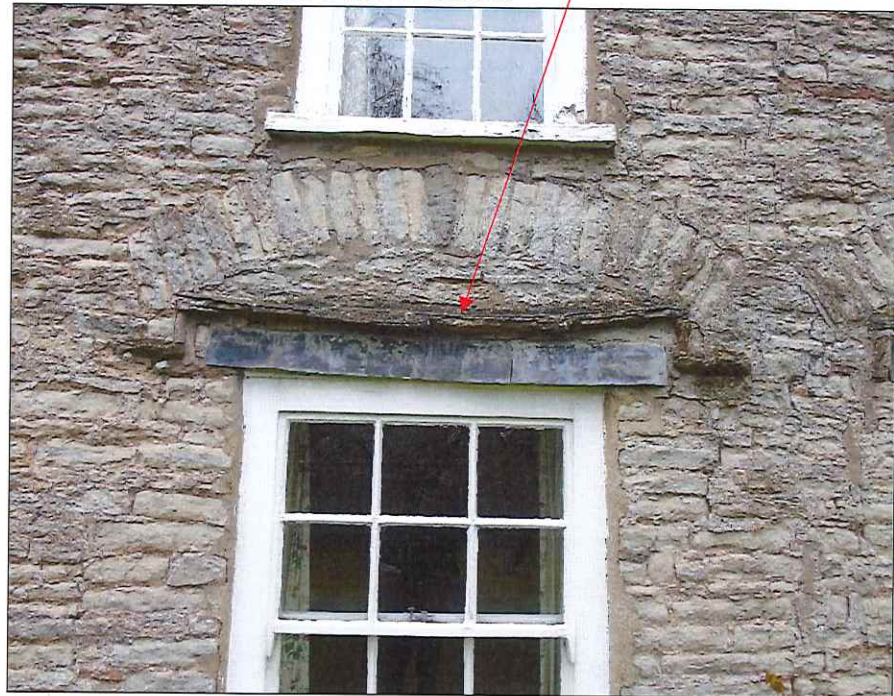
The property has been affected by fairly noticeable movement and distortion over the years visible both internally and externally. Internally, there is fairly noticeable deflection to floors together with distortion over door heads. There are also uneven walls, particularly to the left hand flank wall. Externally, there are noticeable distortions above/below window heads, particularly on the front and left hand side of the building and, to a lesser extent, other elevations. Some structural repairs have been carried out in more recent times including the addition of tie bars on the left hand flank wall and also further strengthening of roof timbers with modern metal brackets. Works of this type should ideally have been carried out under the supervision of a structural engineer and you would be prudent to obtain any information regarding this matter.

Distortion to left hand window heads

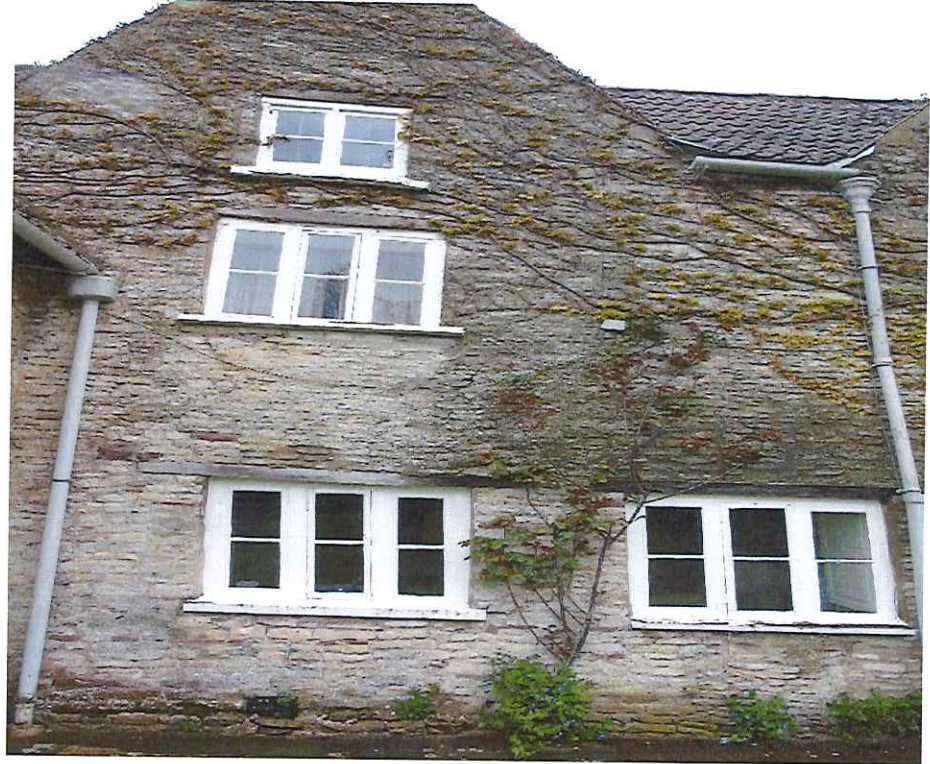
Given the poor condition of timber lintels, there is always the potential for other localised movement to occur if repairs are not affected. As mentioned in the previous section, examination of lintels must be carried out with repair/replacement undertaken. Given the listed status of the building it may be a requirement that any lintels are replaced with timber counterparts although it is possible that some more substantial concrete/metal sections could be incorporated internally as long as they are appropriately hidden from view. Further advice would be prudent regarding these works through a structural engineer.

Distortion over front windows

Action: Make provision for structural repairs, particularly in terms of renewing lintels. Consider further advice from a structural engineer in this respect.

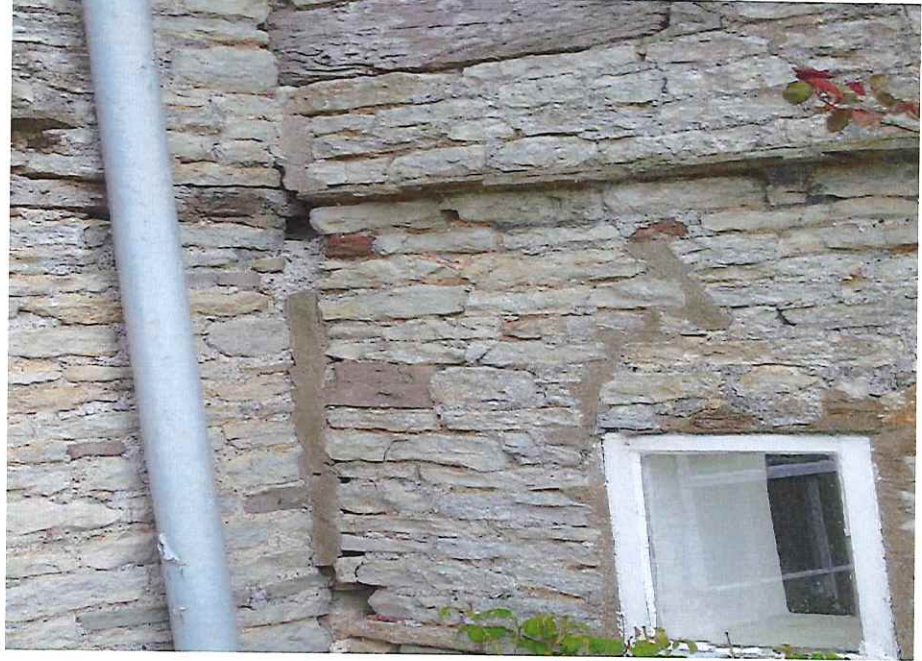
The front porch section appears to have pulled away from the main building in the past which has necessitated the requirement for some basic filling of joints. These should be raked out and filled with appropriate strapping carried out to prevent further distortion.

Filling between porch and main structure

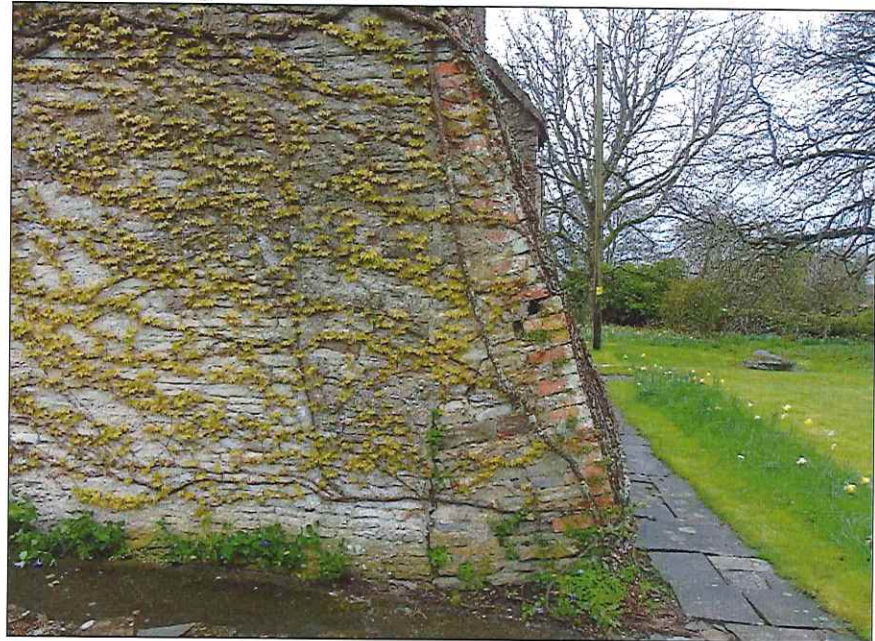
Buttressing has been incorporated on the right hand side of the building, presumably to prevent or reduce movement which has previously occurred to this area of the structure. There is slight cracking/open jointing between the buttress and the main building which should be filled.

Buttress on right hand flank wall

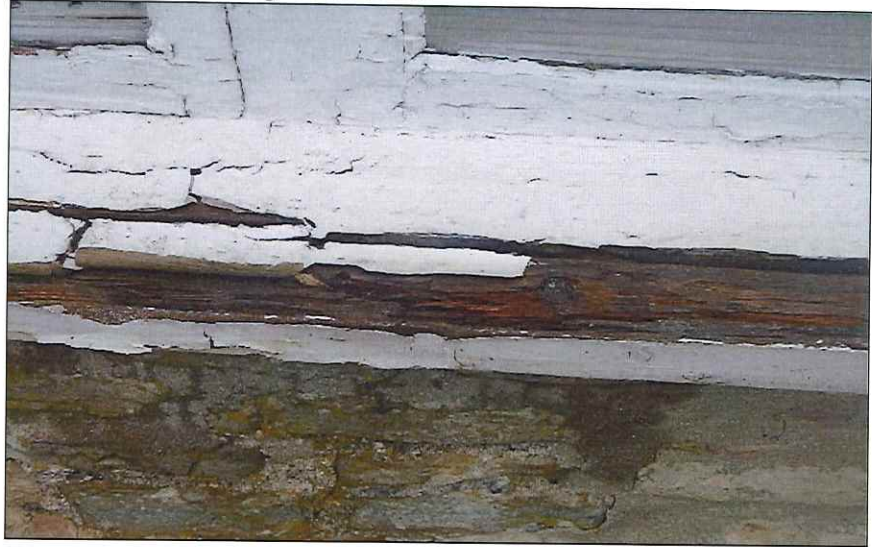
Rot was noted to a number of windows including cills and, indeed, fittings such as sash areas on the left hand flank wall. In addition, it is clear that many of the older cills have been dressed with painted leadwork suggesting rot to lower areas. Overhaul of many of the windows will certainly be a requirement as part of external maintenance.

Rot to cills – front ground floor

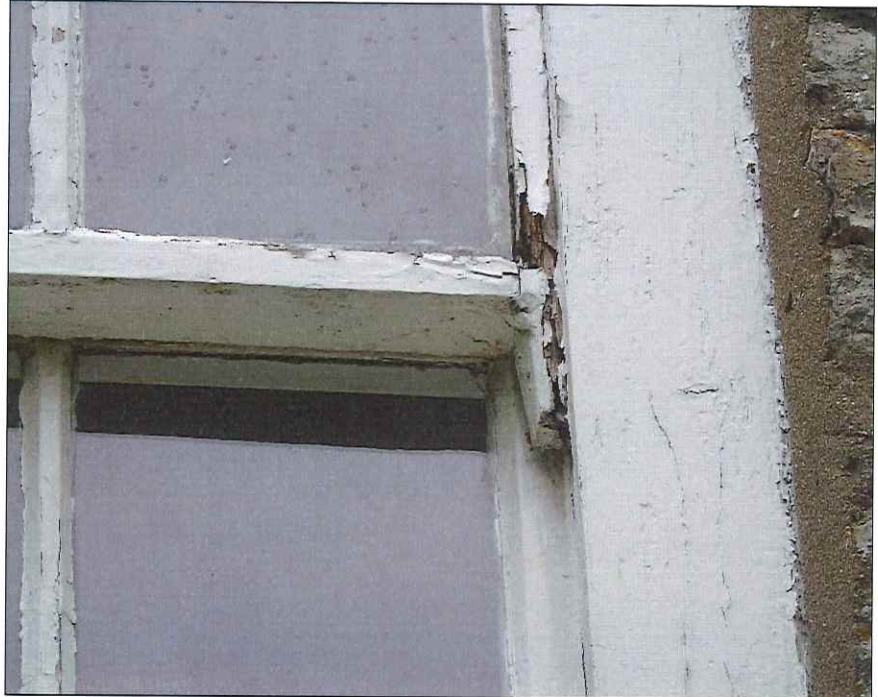
Rotten joinery – left hand windows

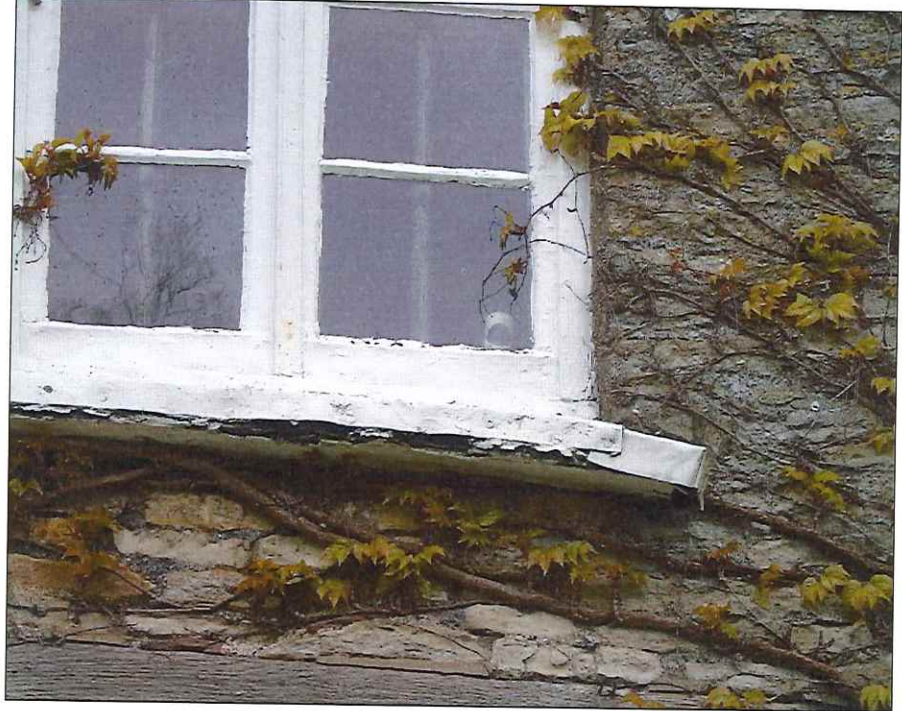
Poor cill – top floor front

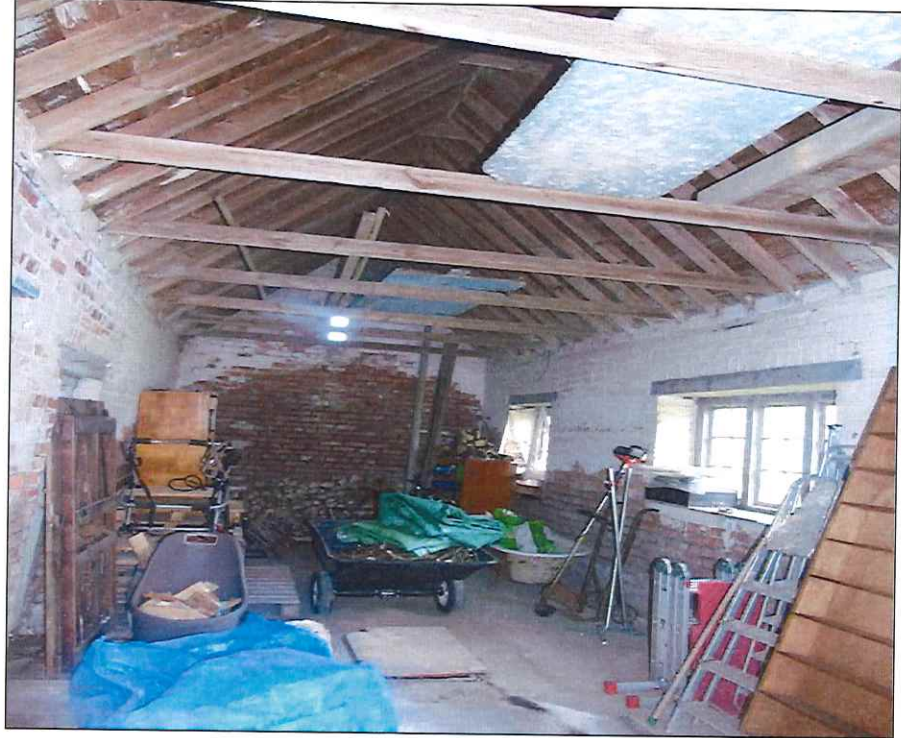
Evidence of dampness is present which has allowed a number of bricks to perish internally and this should be attended to. You are advised not to store valuable or perishable items in this area without taking appropriate measures against damp.

Wood boring beetle infestation was noted to the internal timbers which should be treated by a specialist contractor.

Internal view of garage

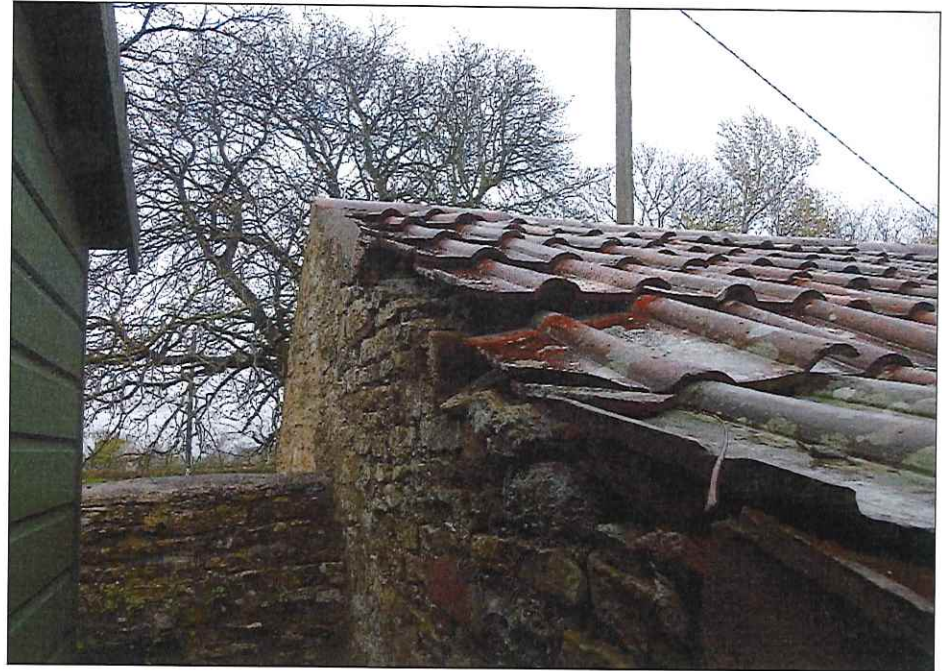
There is an oil tank/coal store in the rear garden which is of stone and timber construction under a pitched and tiled roof. These outbuildings are in rather poor condition and will require overhaul. The roof is clearly leaking due to a number of damaged tiles and the lack of felt underlining below. Rot was also noted to some exterior timbers together with wood boring beetle infestation to internal timbers.

Poor roof on oil/coal store

There are no rainwater goods and new fittings should be appropriately fitted. In addition, cracking internally should be attended to in terms of stitching and filling as necessary.

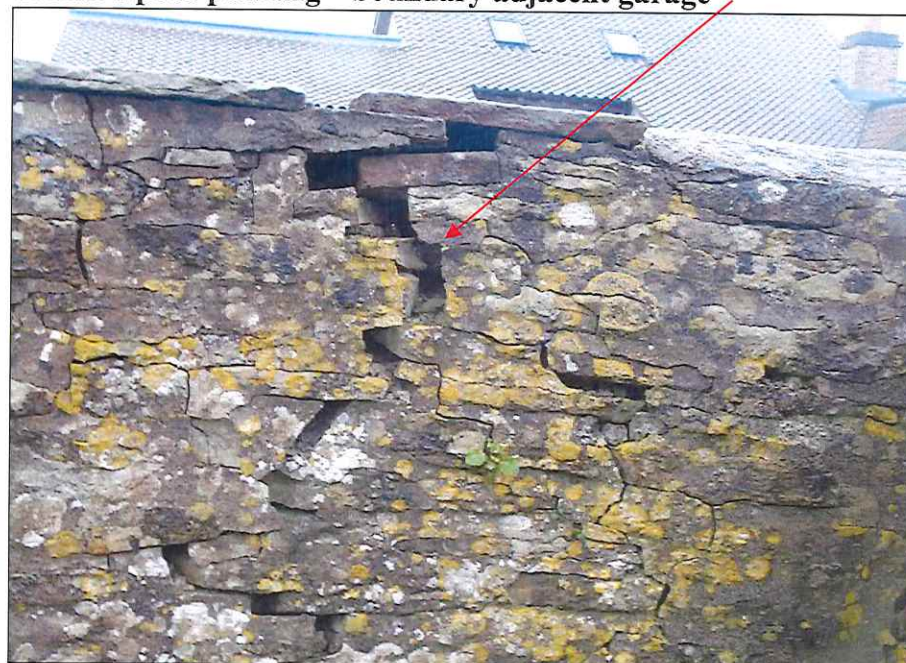
Some repointing of the front stone boundary will be required to include pillar section. There are also large cracks in the stone boundary adjacent to the garage which should be repaired.

Cracked/poor pointing – boundary adjacent garage

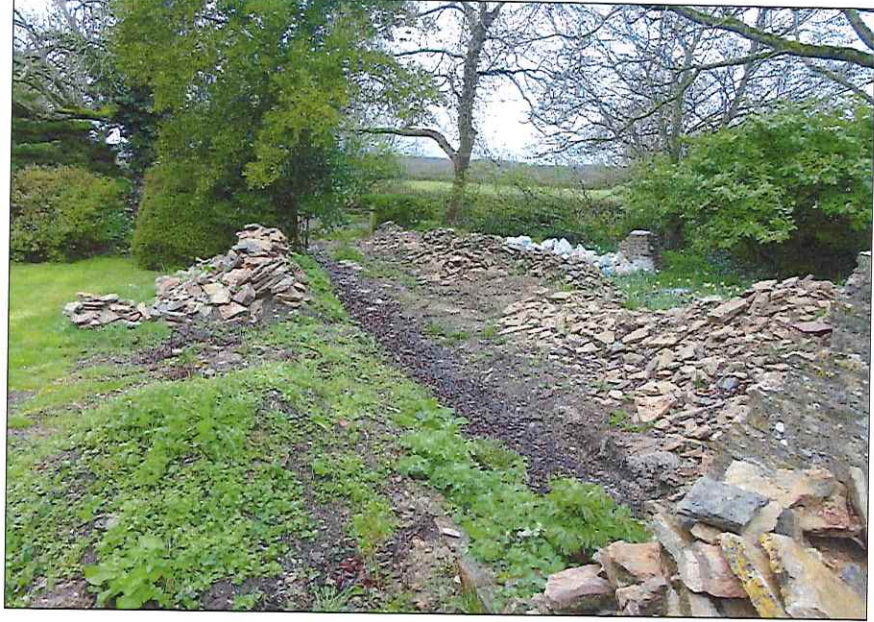
Reconstruction of a boundary wall in the rear garden is to be undertaken in due course although we cannot confirm that this will be completed prior to any occupation.

Stone wall to be rebuilt

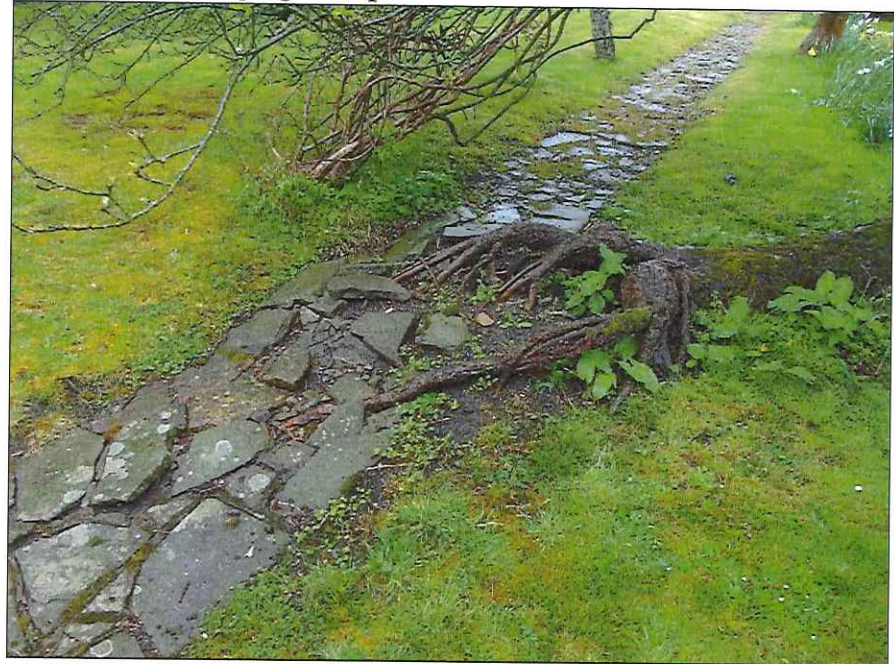
Tree roots damaging rear path

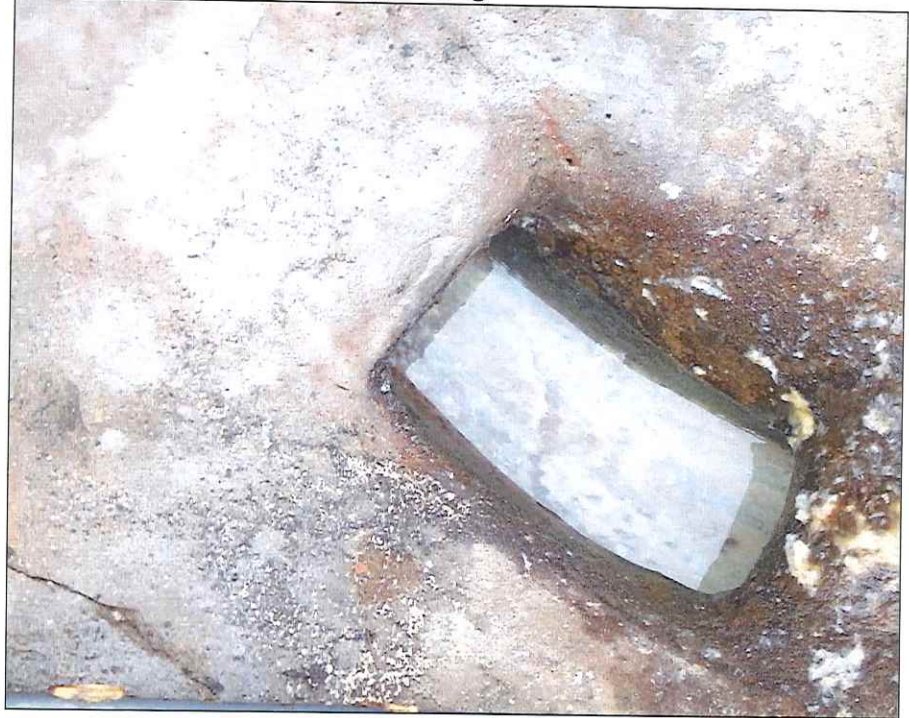
Maintenance hole covers were lifted adjacent to the property and we did note some general ponding and waste build up. This suggests slightly shallow drain runs and it is therefore important that rodding through be undertaken. You would be prudent to have a CCTV test of the drains carried out, particularly bearing in mind proximity of tree roots close to the drain runs which may potentially be causing the slight blockage.

Drain runs require rodding through

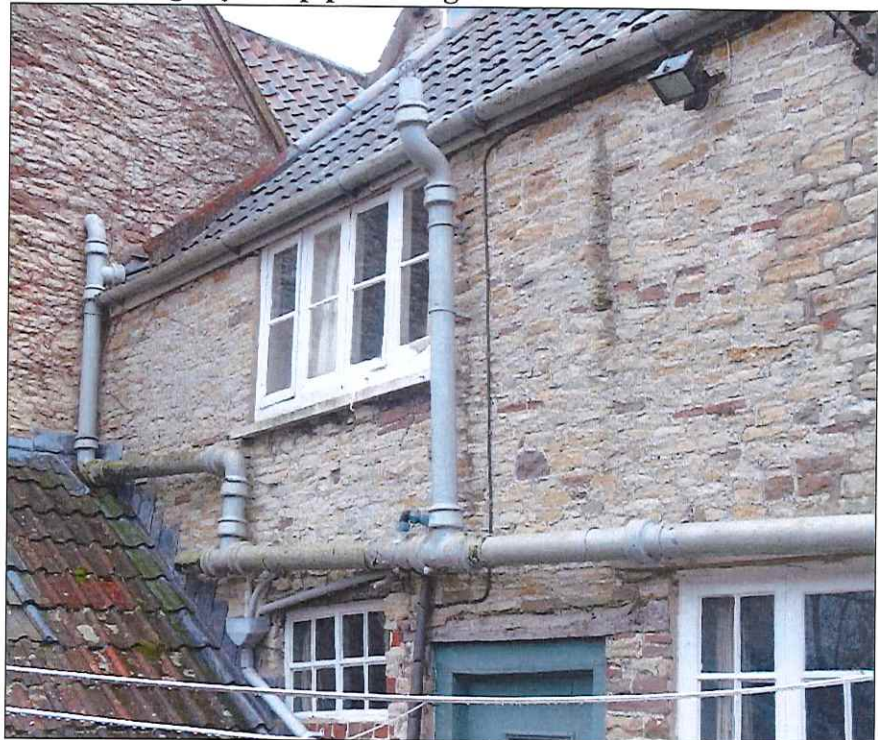
Soil and ventilation pipes are present at the rear of the building and these are rather unsightly in part. Some appeared to be of older cement asbestos material and may be nearing the end of their useful life. Drainage ditches were noted adjacent to the main road. We are unaware of any flooding having affected the site although this should be raised as a specific question by your legal advisers.

Rather unsightly soil pipe arrangement

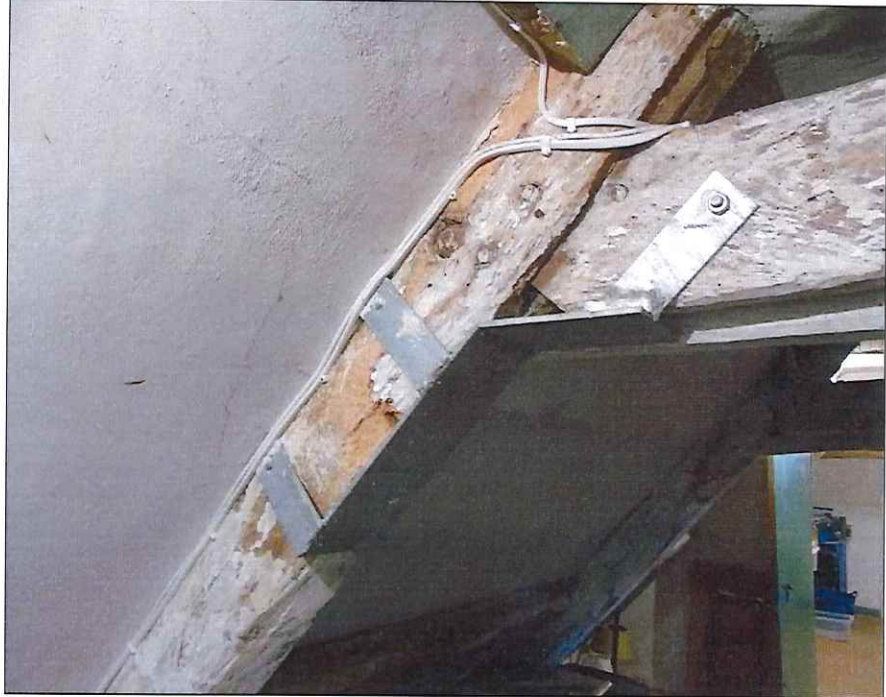
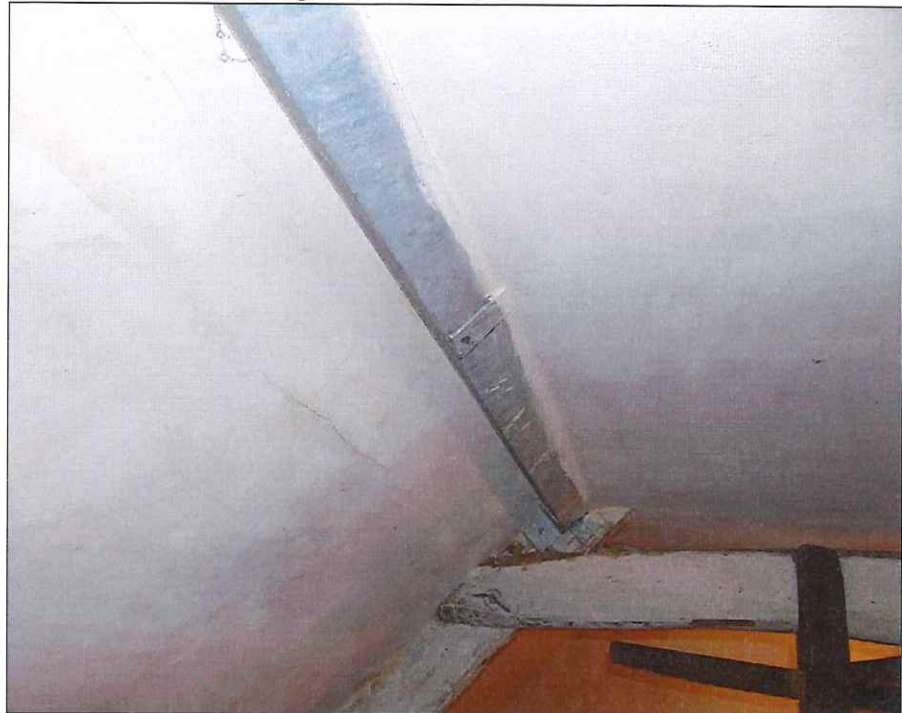
Attic rooms have been incorporated with exposed timbers in many areas. There has been some recent strengthening/bracketing incorporated, particularly in the right hand void and, to a lesser extent, parts of the left. Works of this type may have been undertaken in conjunction with structural engineers advice and we suggest this be raised as a specific question.

Bracing on roof timbres

Modern bracing in right hand loft room

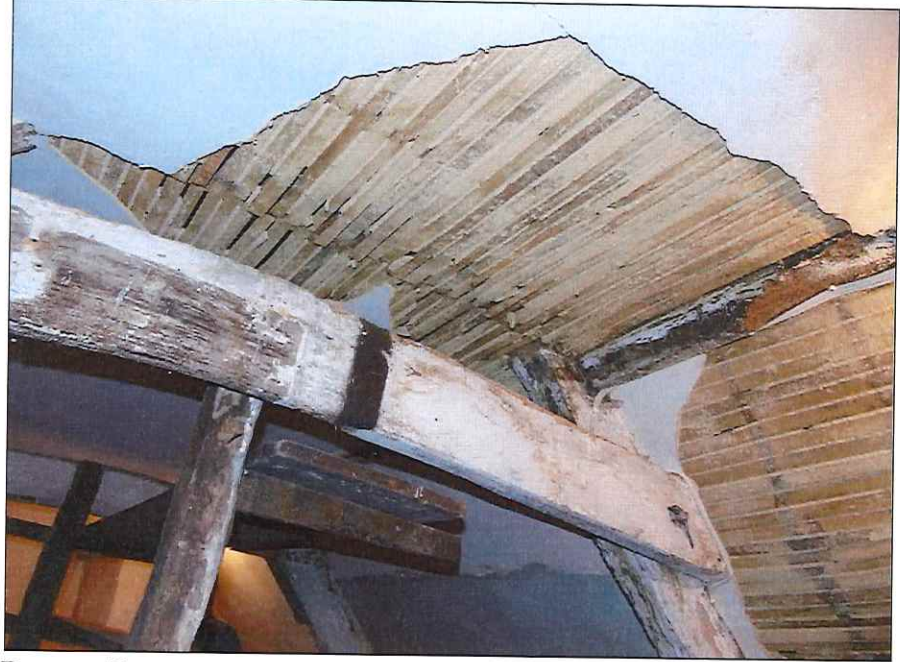
Poor ceilings are present in the attic rooms, particularly on the right and also the rear left where defective plaster should now be renewed.

Poor ceiling – right hand loft room

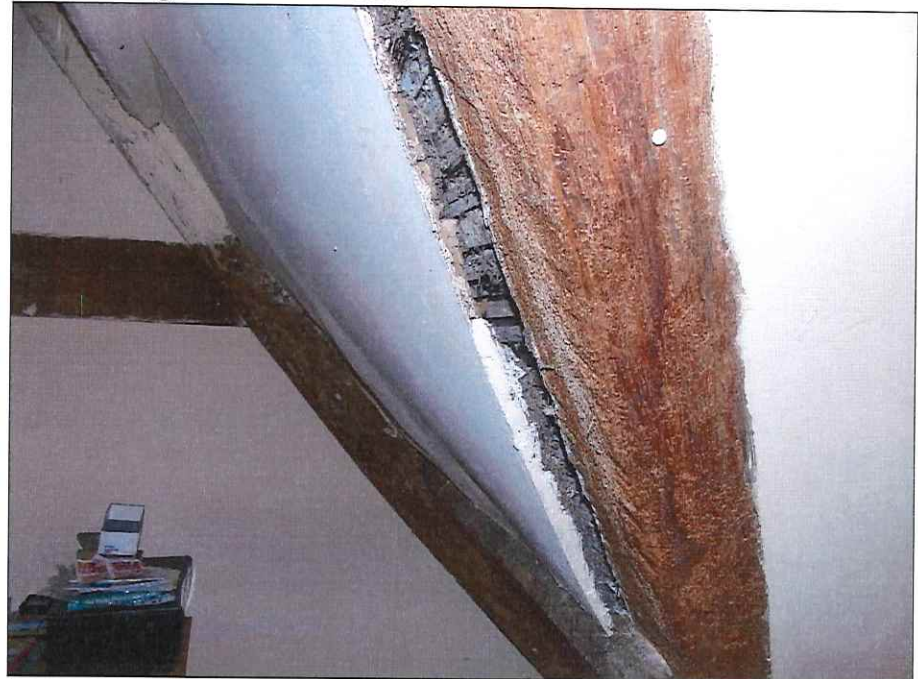
Poor ceiling – rear attic room
