FULL BUILDING SURVEY

**Lynbrook House
Stocks Lane
Bristol
BS14 7DG**

10 October 2019

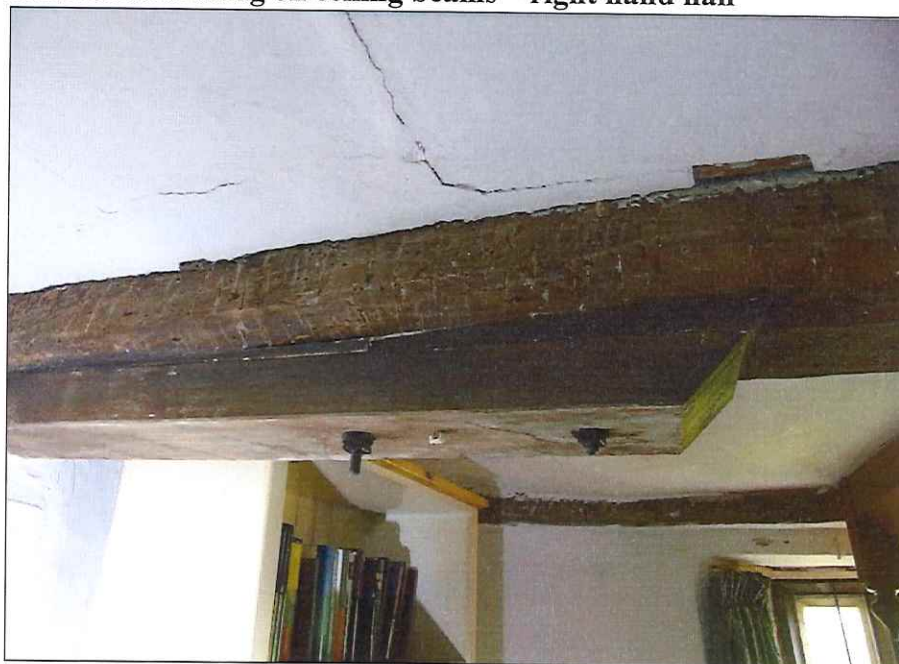
There are many exposed beams throughout the house giving an attractive feel to the ceiling areas. Some bolted repairs have been carried out to beams such as those in the right hand hallway and no obvious ongoing issues were noted.

Additional bracing on ceiling beams – right hand hall

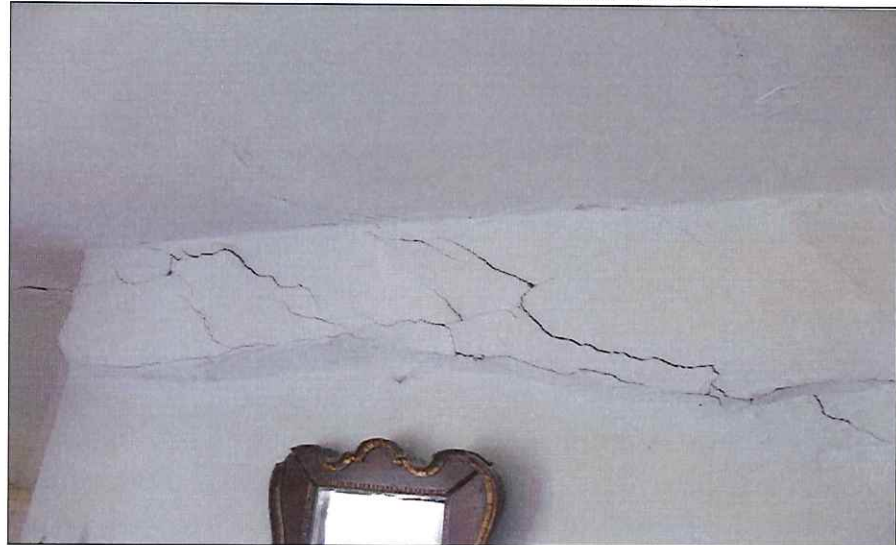
Cracked plaster on left of first floor accommodation

Cracks were noted, particularly in the left hand part of the property including the left hand bedrooms and, indeed, the partition between the two left hand bedrooms. It is likely that some stitching in of cracks will be required in conjunction with replastering.

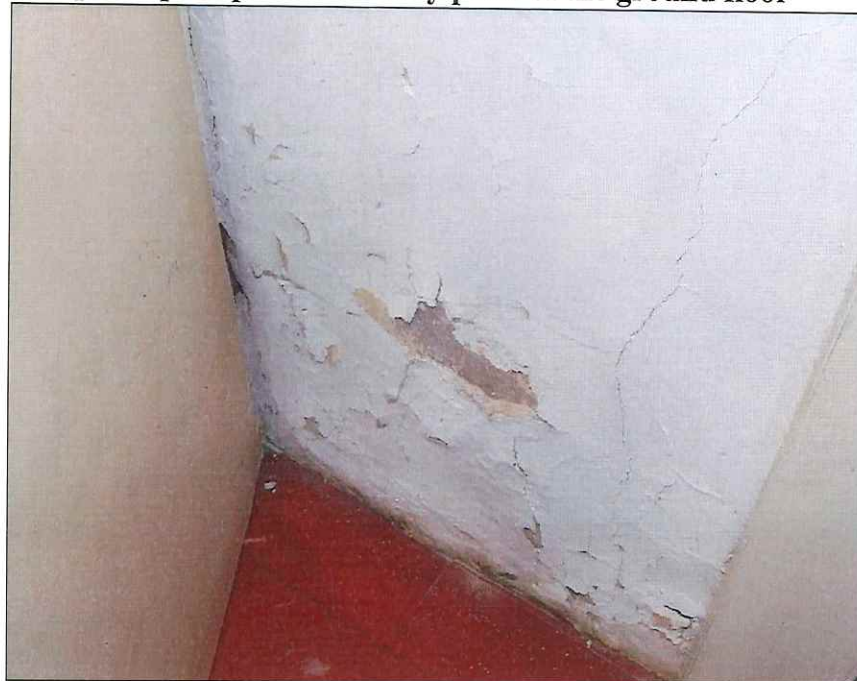
There are many areas of uneven and hollow plaster throughout the property. Some replacement plaster will be required although, again, one should be mindful of the listed status and further advice will be required from the Listed Building Department of the Planning Authority in regard to suitable finishes.

Damp and poor plaster in many parts of the ground floor

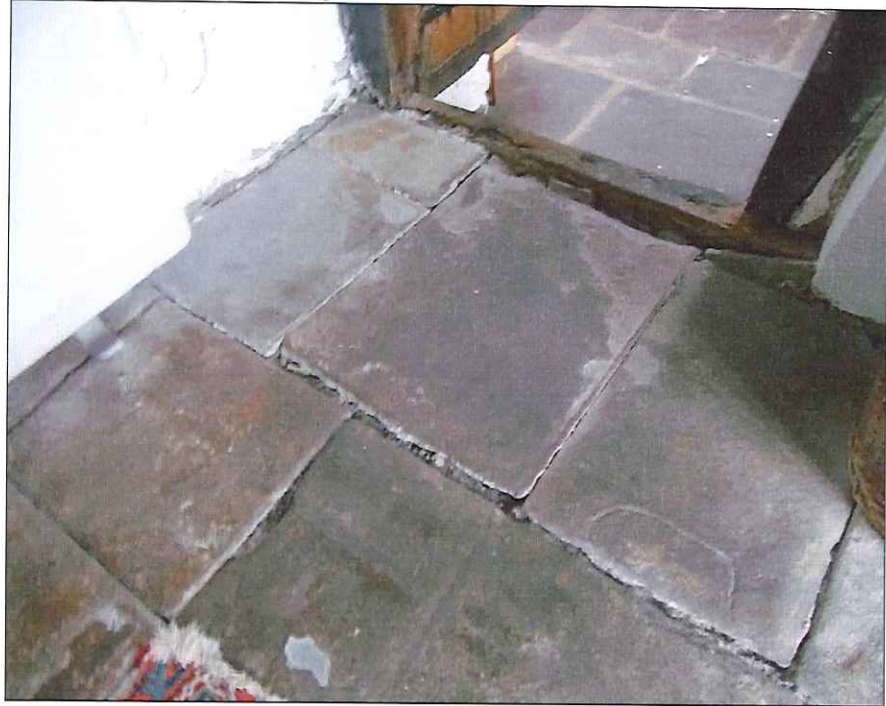
Uneven flagstones in right hand hall

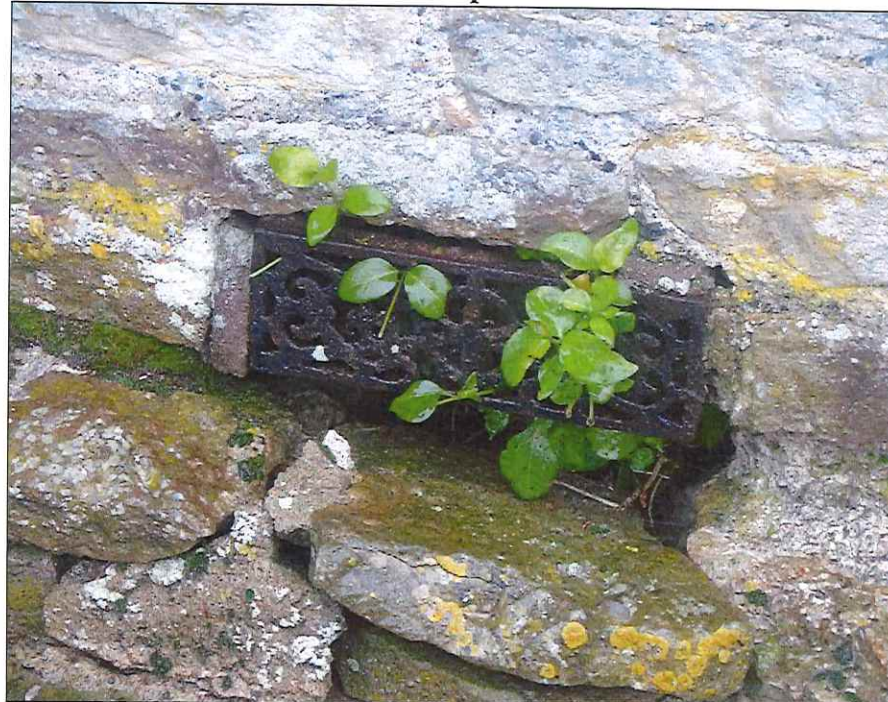
Sub floor ventilation should be improved

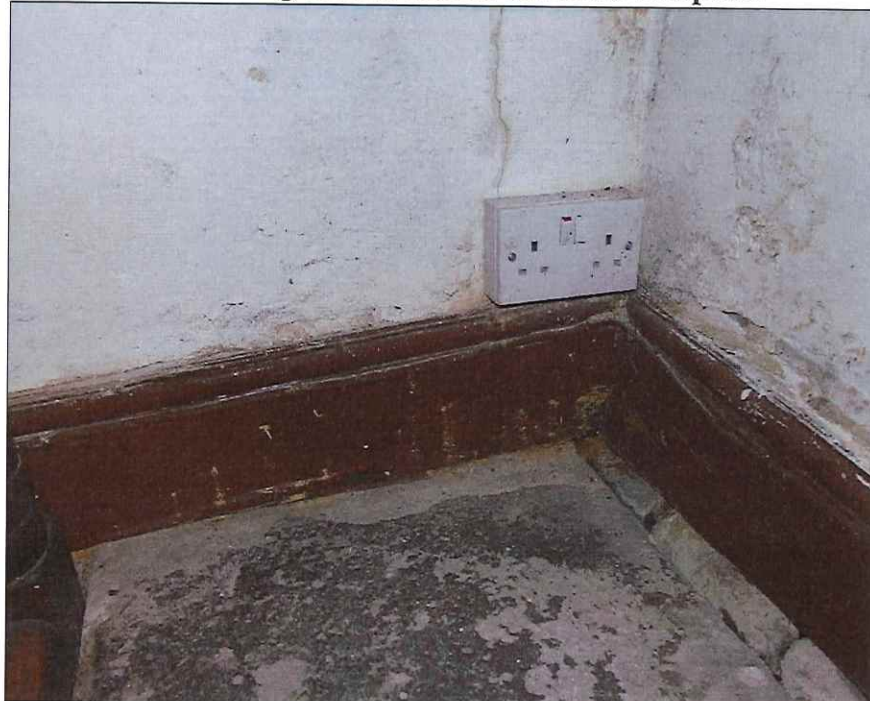
Worm/rot in skirting boards of rear left hand reception

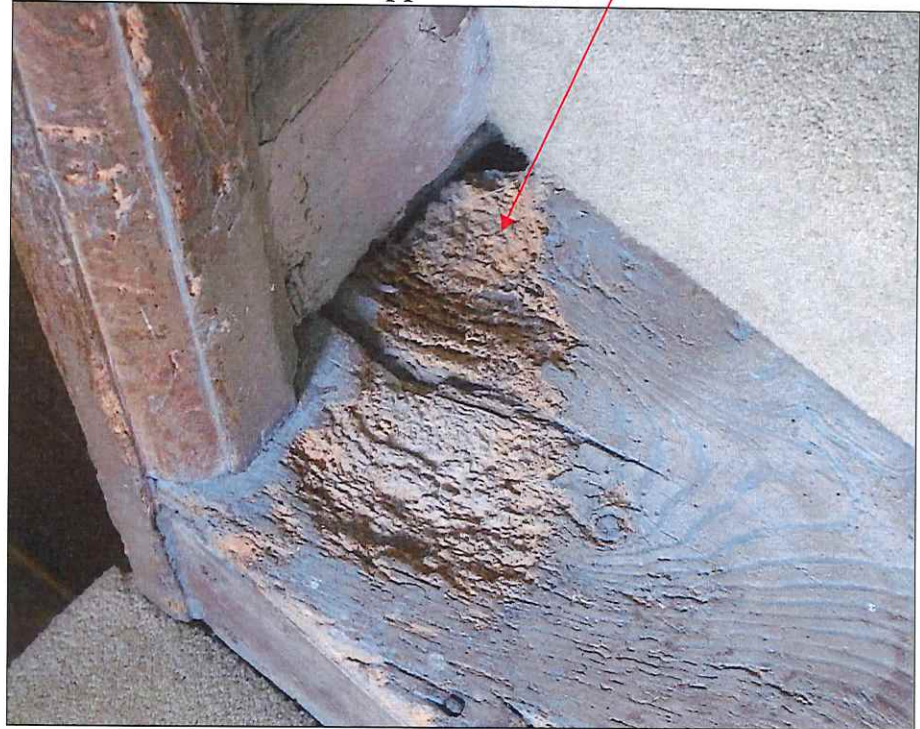
Evidence of wood worm – upper staircase

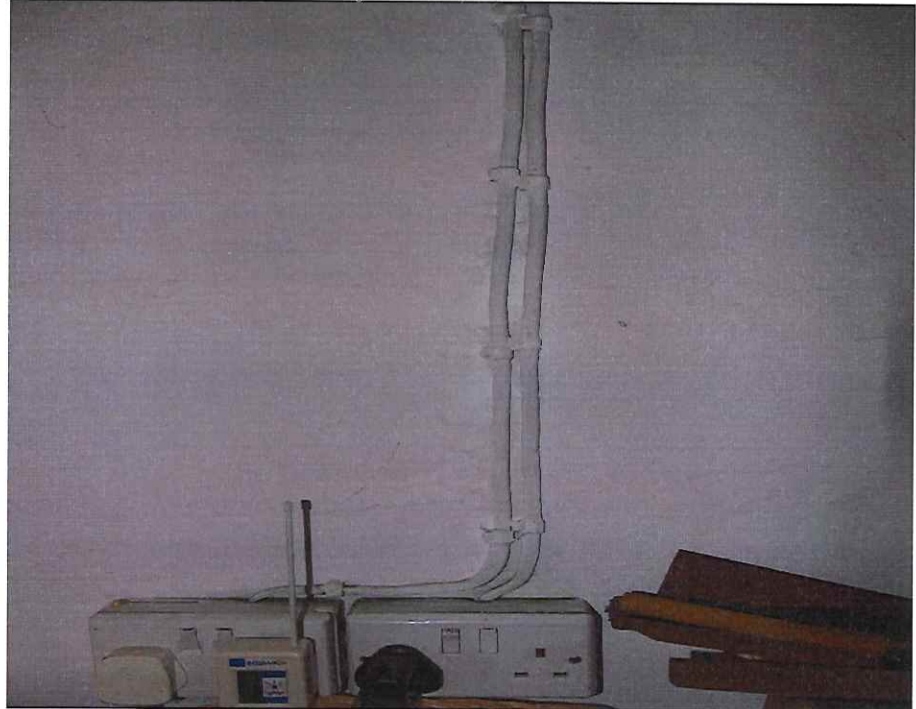
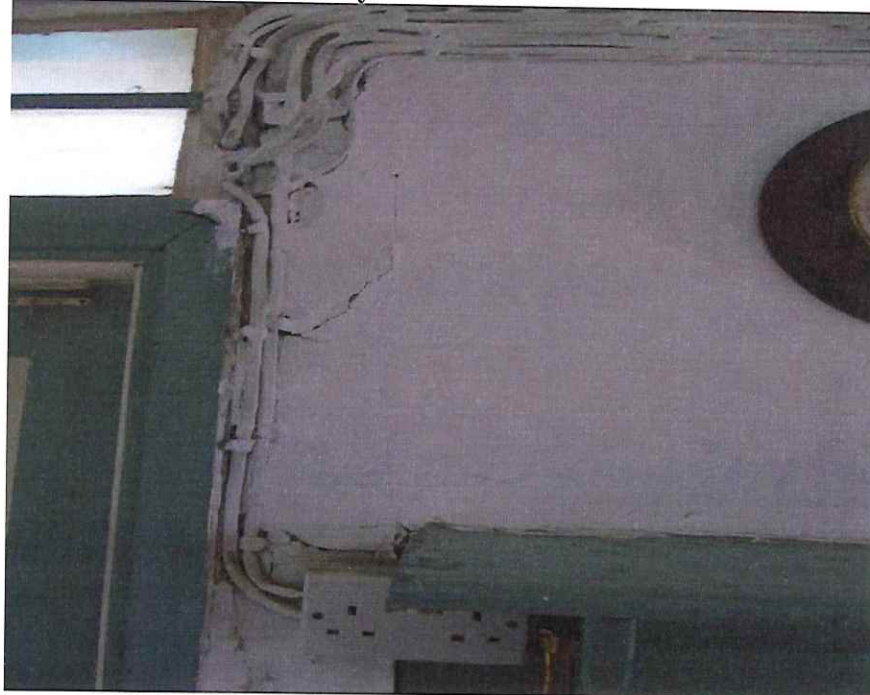
Surface laid cable to many areas

Surface laid cable in many areas
