**ROOF INSPECTION**

**Lynbrook House  
Stocks Lane  
Bristol  
BS14 7DG**

**30 September 2019**

**MOH/mbo/19.0667**

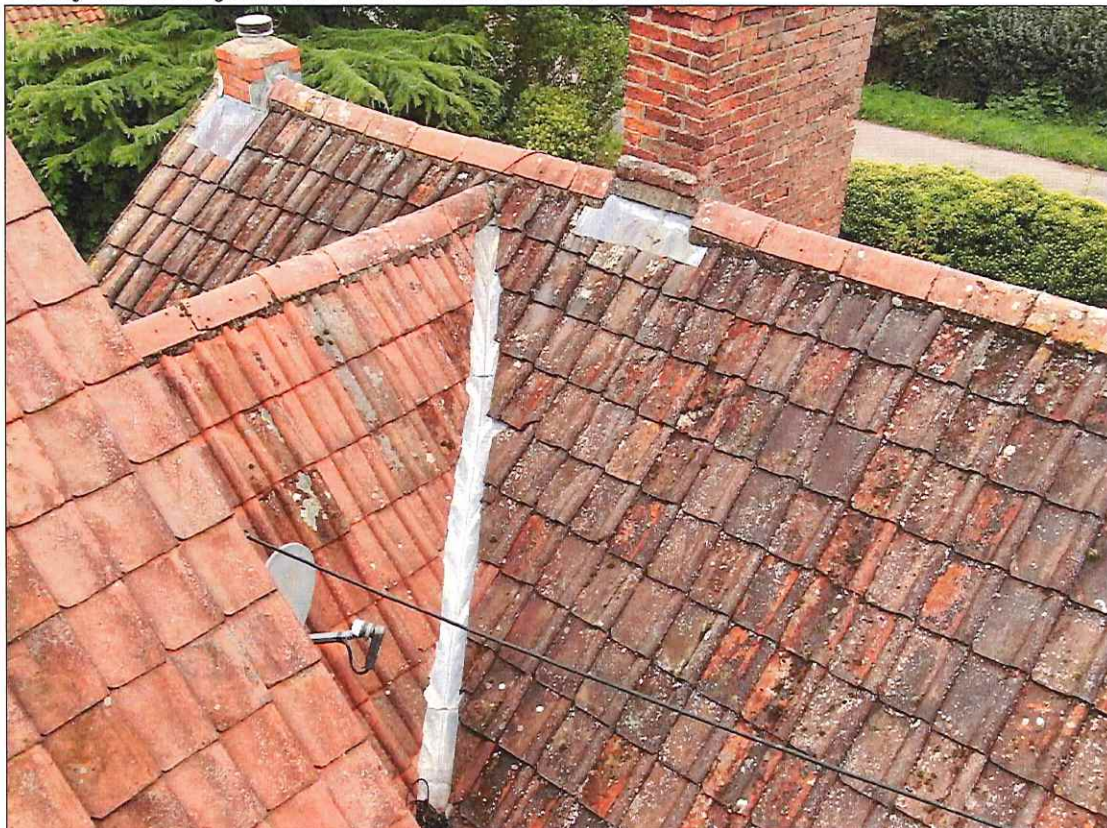
**Valley detail at joint between main roof and “annex”**

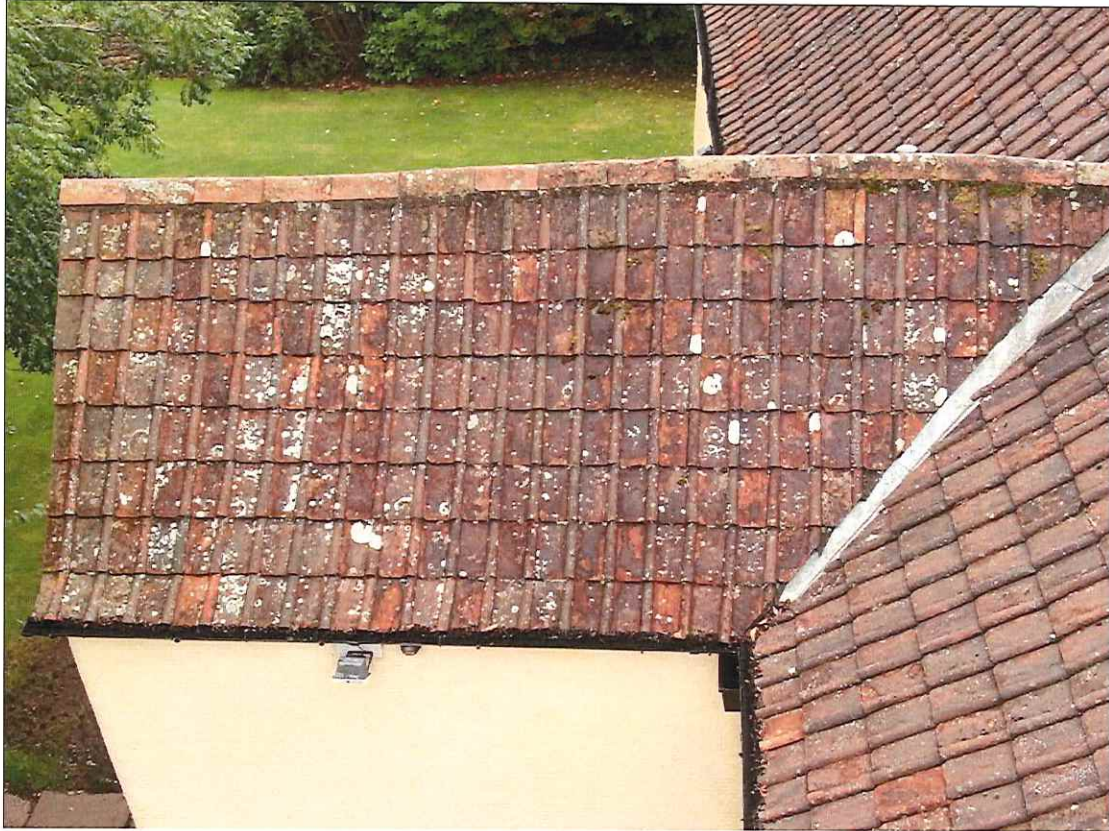
During the survey we noted evidence of slight deflection, particularly to the front central part adjacent to what is considered to be the left hand front dormer. There is also slight deflection to ridge sections on both the main parts and, indeed, the front gable protrusion. These are by no means unusual or particularly excessive for a building of this age and type and distortions are within acceptable limits. In relation to the slight sag to the slopes themselves, we have not had access to any timbers below and do suggest that a cautionary inspection be carried out to ensure that no issues in terms of split or damaged rafters are present at this particular point.

**Front gable roof – slightly uneven ridge**

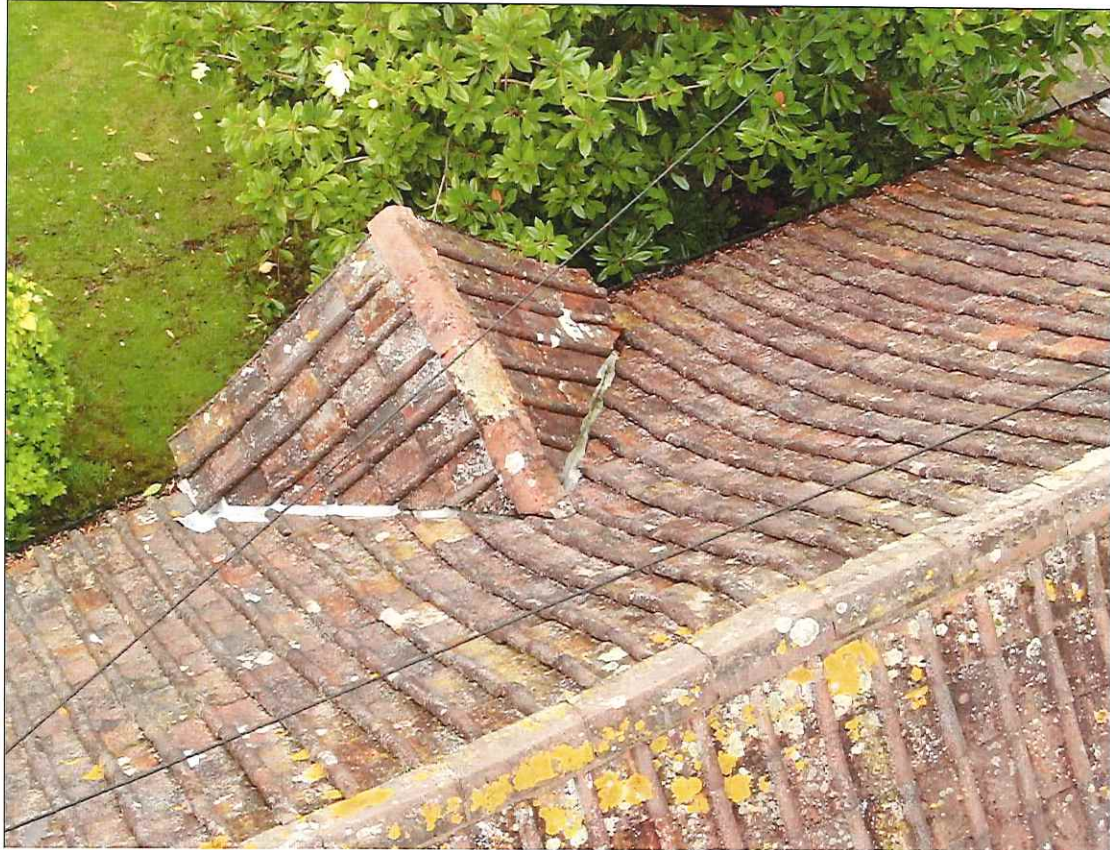
There are three dormers at the front together with two at the rear which appeared to be of timber frame construction under small pitched and tiled roofs. No obvious defects were noted to the tile coverings on these dormers.

**Rear left hand dormer**

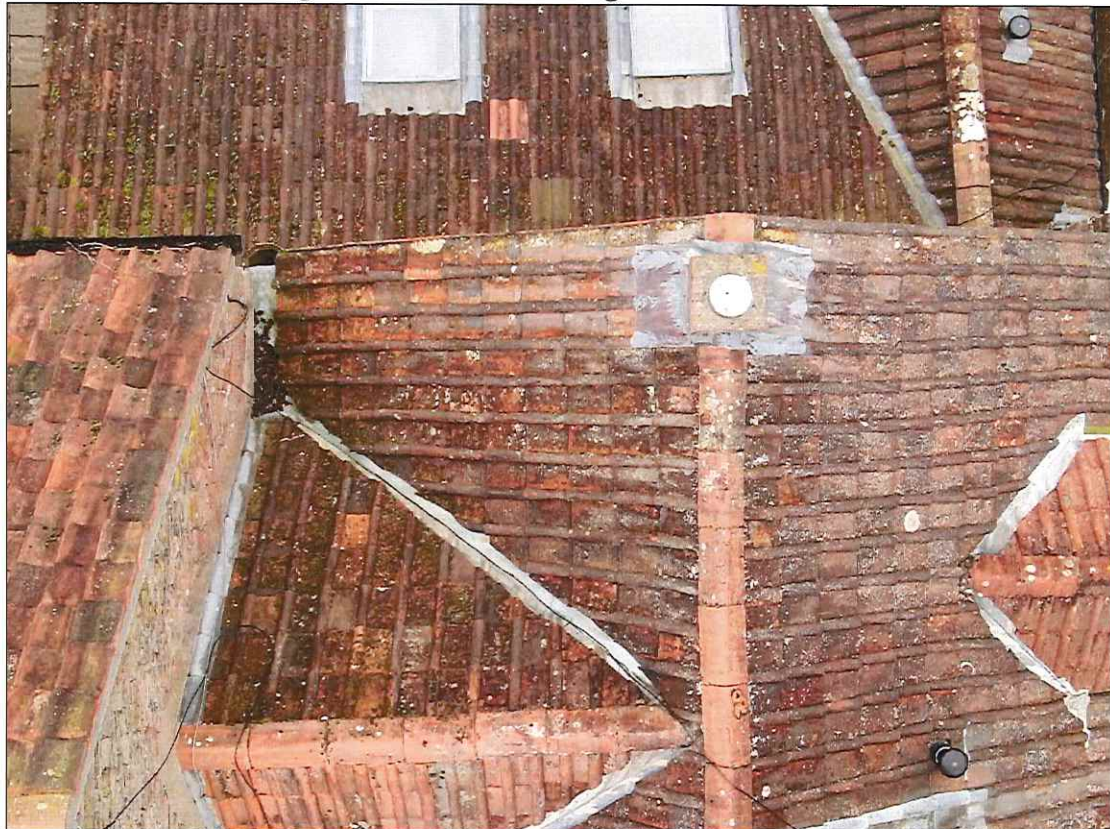
**Valley/roof detail – right hand main covering**

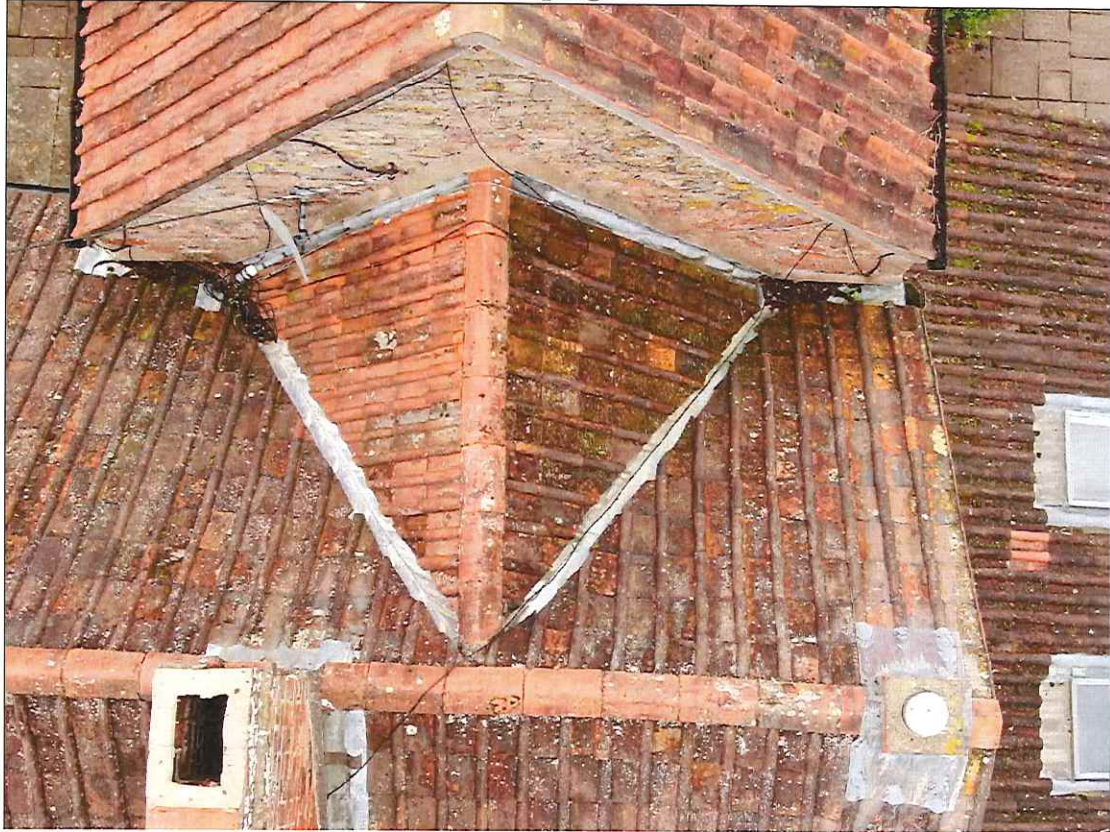
Sloping valleys have been incorporated at the joint between the dormers and the main front and rear slopes with six at the front and four at the rear. There are also two slightly larger sloping valleys at the intersection between the main front slope and the protruding gable section. Valleys appeared to have been lined with lead. Additional valleys can be found on the rear right at the intersection between the main building and the slightly more modern rear two storey section. Valleys are notoriously prone to blockage and deterioration and can be a frequent source of water penetration internally which can cause deterioration to timbers and other materials. Regular checks on linings will be required with any blockage removed as soon as possible. No major debris was noted although one or two individual areas of slight deterioration are present,

particularly at the rear although this is not unexpected or particularly excessive. Cleaning out should be considered.

**Valley detail – note debris at base of sloping section**

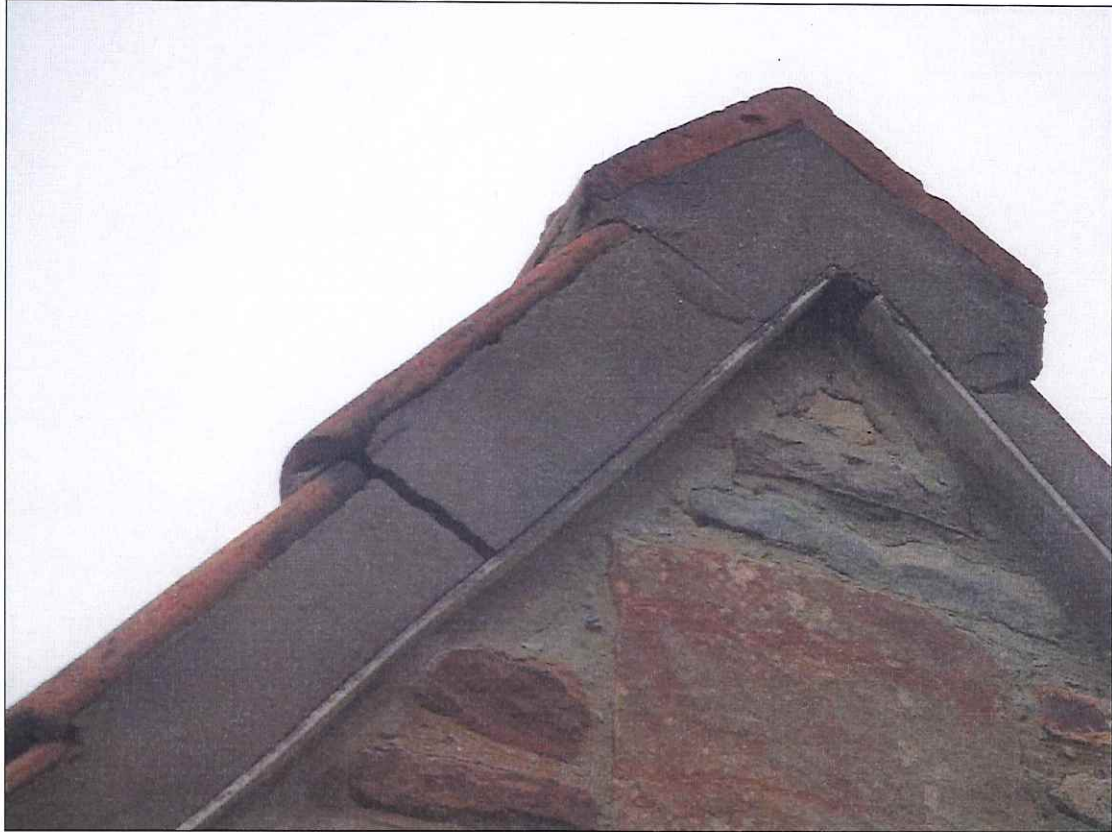
Tiles themselves were in satisfactory condition although very minor cracking is present to the cement verge overhangs on the gable ends where filling will be required to prevent further deterioration. Failure to do so may allow water penetration internally.

**Cracked cement verge – rear gable**

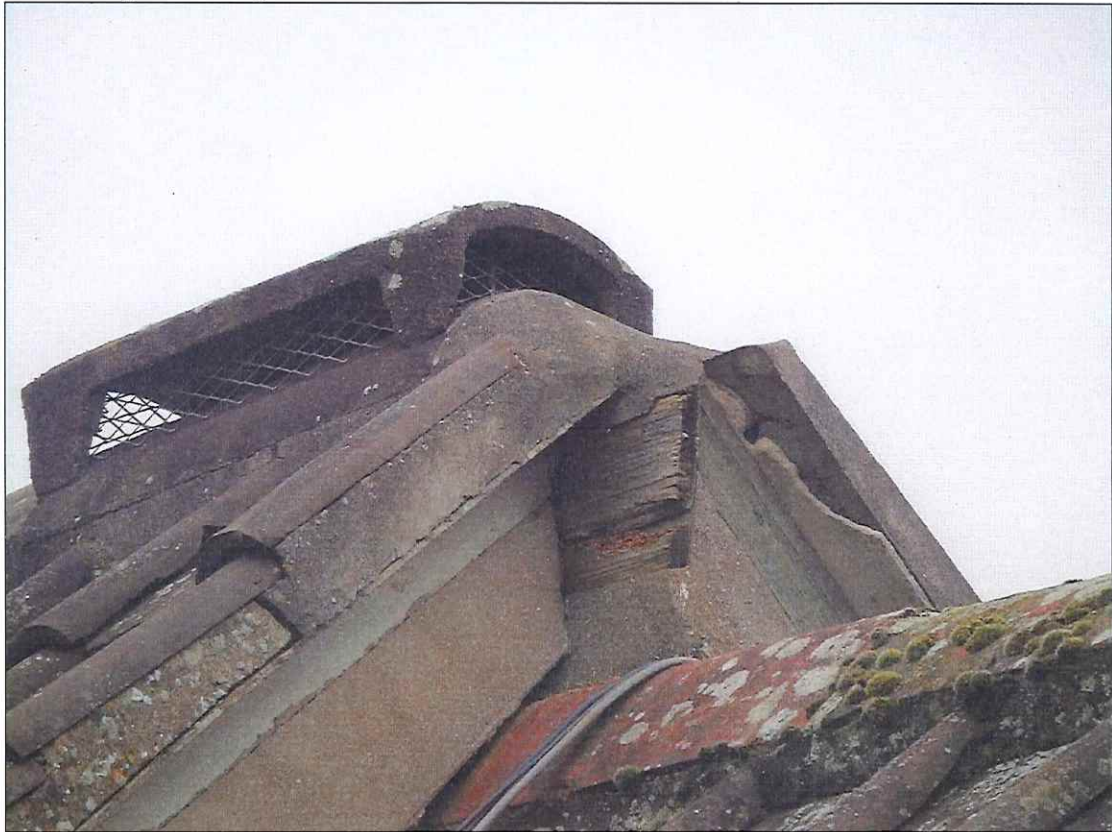
Tiles themselves appeared to be in satisfactory condition although one or two are losing their surface glaze although this is not excessive at the present time. No immediate replacement is necessary. We did note slight deterioration to an exposed ridge board adjacent to the upstand between the left and right main sections which is highlighted in adjacent photographs. For ease of reference, this is positioned close to a ridge vent/flue. Making good of any defective timbers should be considered although this can perhaps be pasted and treated in the interim period to minimize costs.

**Rot to exposed ridge timber**

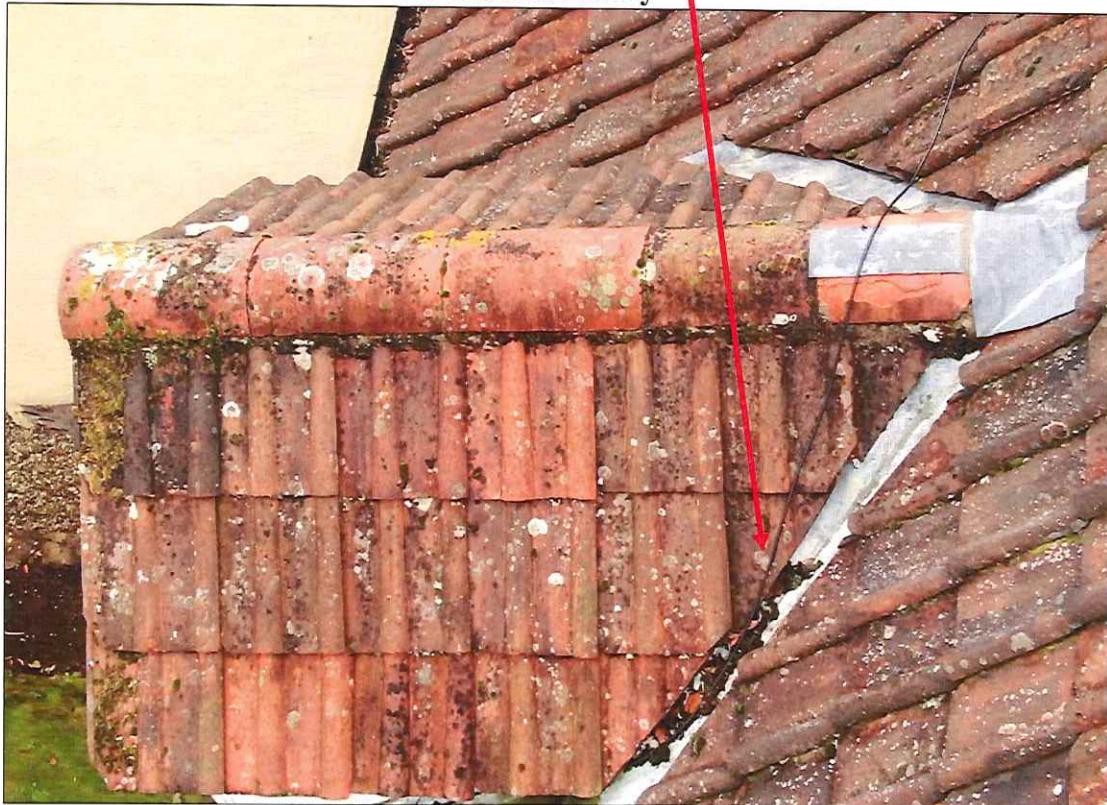
**Left hand front dormer – minor debris in valley**

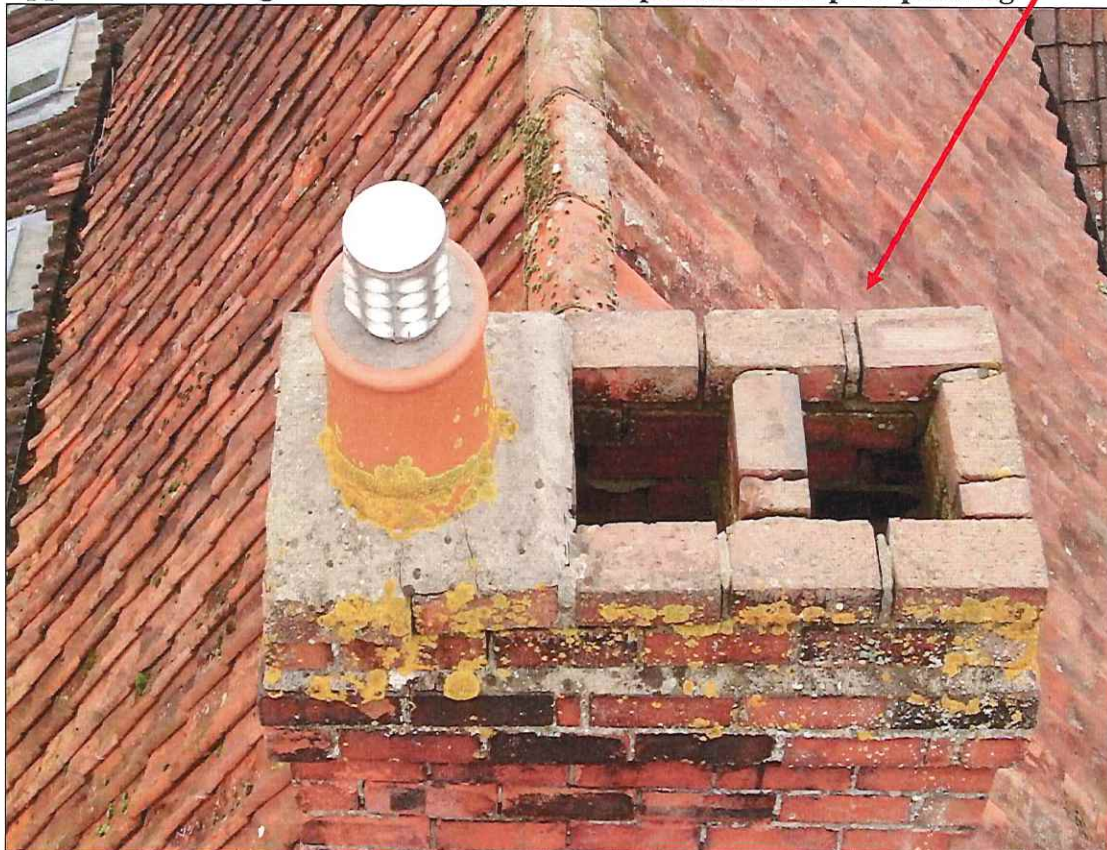
Brickwork and pointing itself is deteriorating as highlighted in adjacent photographs. Raking out and repointing is recommended and, at this time, any spalled bricks should ideally be replaced.

Open pointing is also present on the upper parts of the stacks and minor cracking is also identified to the cement flaunchings holding pots themselves. Filling and making good should be considered.

**Upper section of right hand rear stack – note open flues and poor pointing**

Where flues are currently open we strongly recommend that these be provided with pots or venting cowls to prevent bird, water or debris entry.

**Action: Overhaul chimney stacks in terms of repointing together with provision of appropriate pots and venting cowls where necessary.**

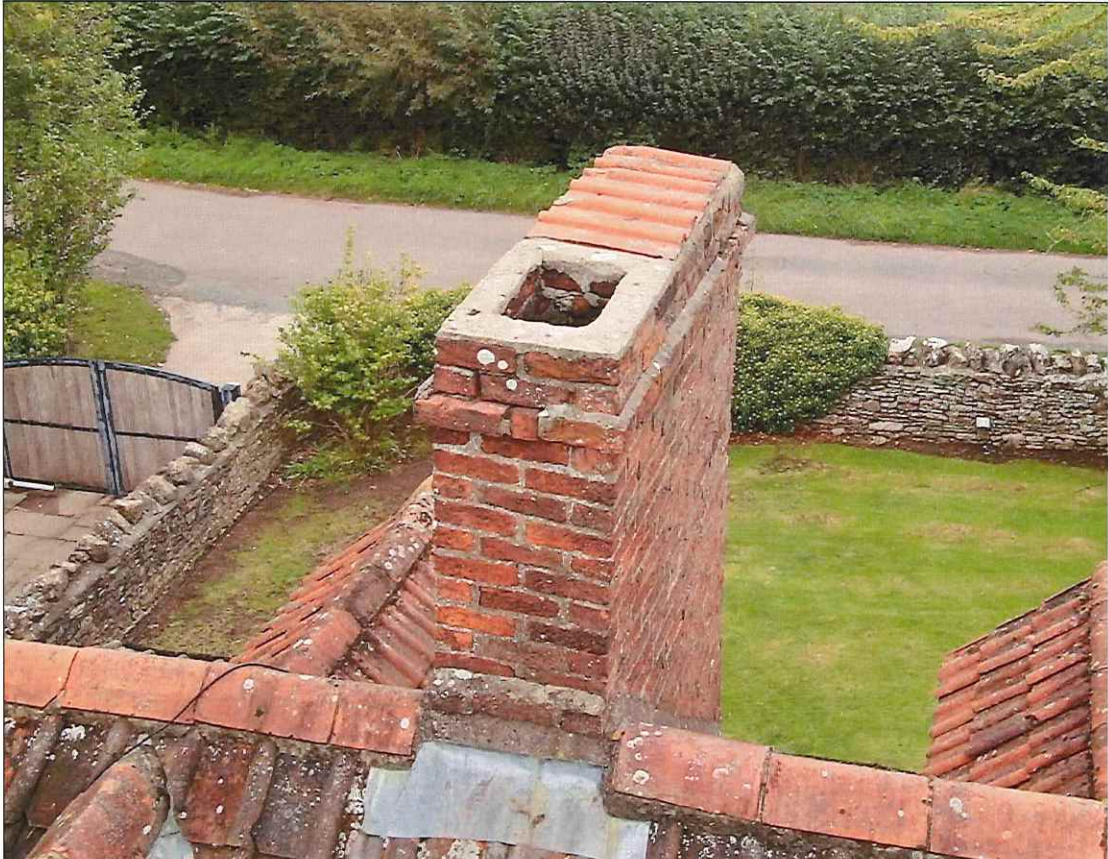
**Large front right hand stack – open flue and poor pointing**
