FULL BUILDING SURVEY

**Lynbrook House
Stocks Lane
Bristol
BS14 7DG**

10 October 2019

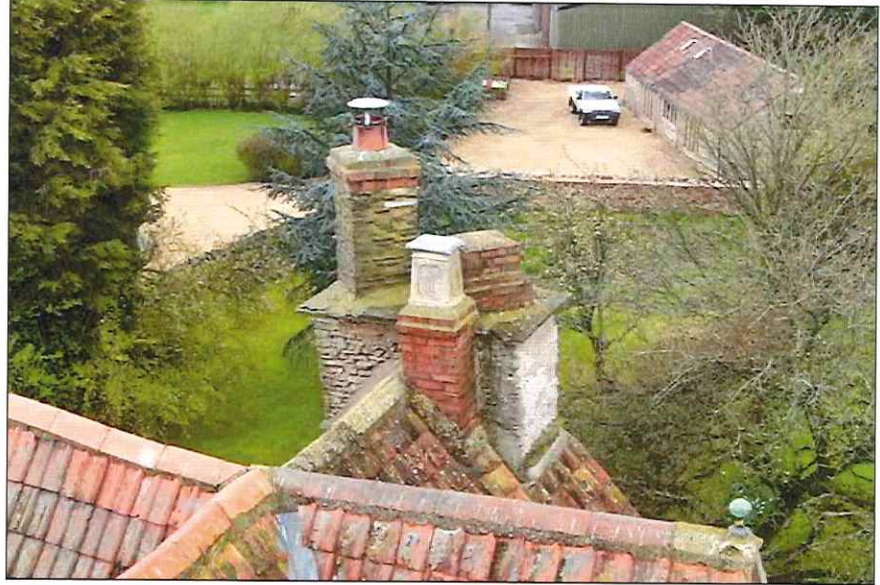
Aerial Photograph of Rear left hand stack

A number of the stacks have pots whilst others are completely open, as can be seen in adjacent photographs. Some pots have been provided with cowl covers, particularly on the rear left hand stack which should prevent bird, water or debris entry. Others which remain open will be subject to bird, water and debris entry and it would be prudent to consider the addition of pots or similar preventative measures to reduce potential problems.

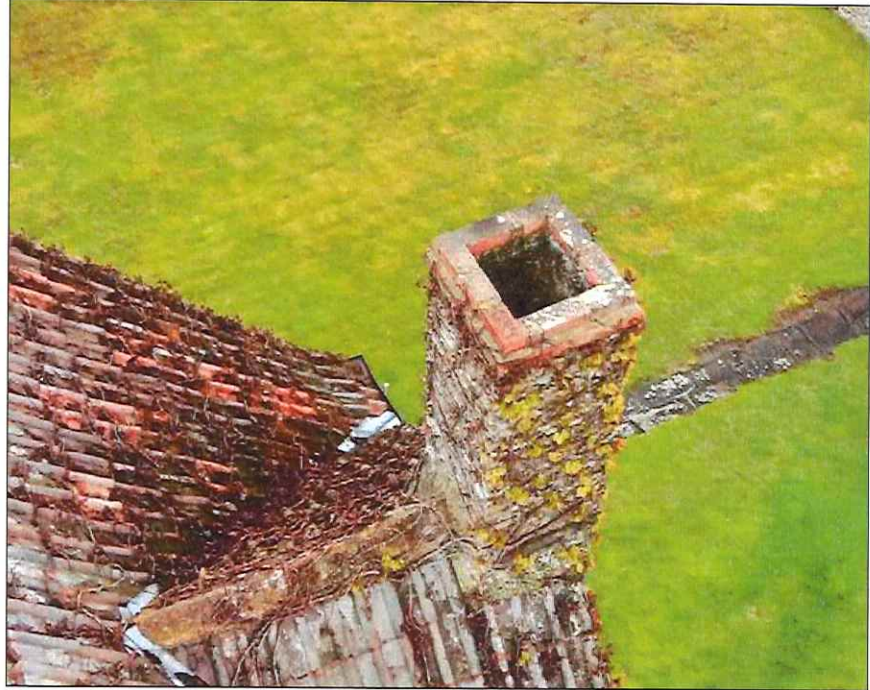
Aerial Photograph Front right hand stack

There is evidence of distortion to stacks, perhaps the most noticeable on the front left hand stack which can be seen in adjacent photographs. This is not considered unusual for a building of this age and character although the situation must be carefully monitored. There may well be the requirement for some reconstruction should distortion persist.

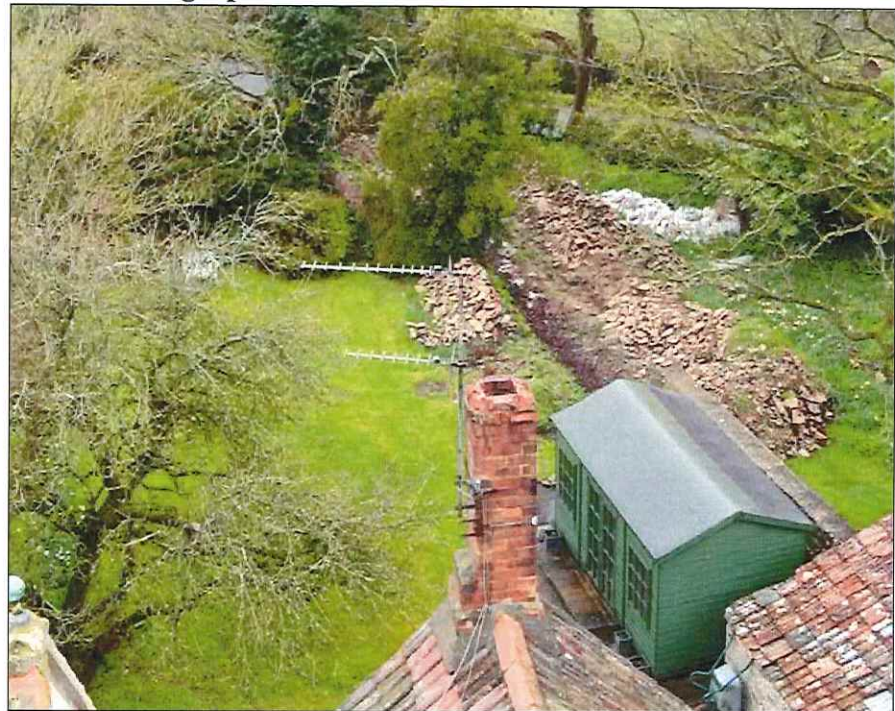
Aerial Photograph Rear centre stack

In relation to brickwork, there is evidence of fairly noticeable spalling, particularly to the rear centre stack. Pointing is also poor and repairs are recommended. Cutting out and replacement of any defective bricks together with provision of new cement mortar should be undertaken.

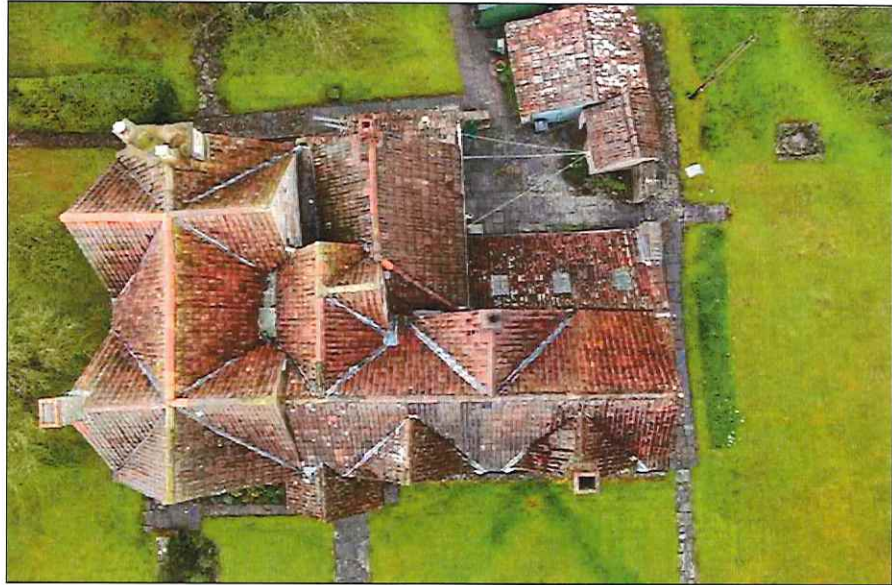
Aerial View of roof configuration

There is a degree of distortion to roof slopes, consistent with many properties of this age and type. Perhaps the most obvious areas are the left hand sections which give the appearance of sloping gently inwards to the central points. There was no indication of any recent deterioration and distortions are within acceptable limits. The roof slopes themselves are laid to appropriate gradients for double Roman and pan tile coverings of this type.

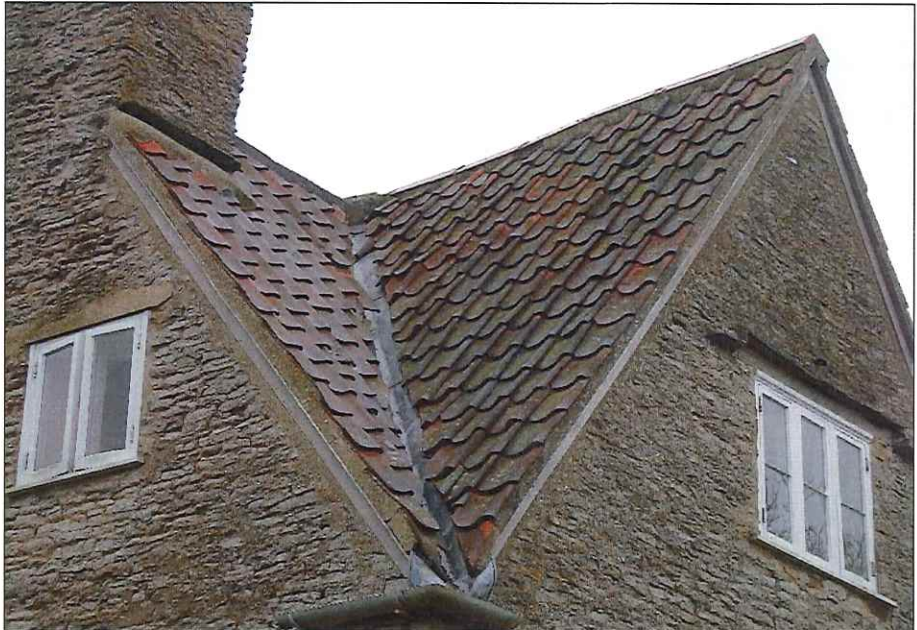
Typical valley detail

This is a relatively complicated roof structure and incorporates some eighteen sloping valleys, two main horizontal valleys and two smaller horizontal valley sections. These are generally lined with lead and were viewed from our vantage point at ground level and also using drone technology. Valleys are notoriously prone to blockage and deterioration and can be a frequent source of water penetration internally which can cause deterioration to timbers and other materials. During the survey there was evidence of some previous leaking, particularly visible on the first floor rear landing area adjacent to the WC although this appeared to be historic. Some patch repair has been carried out to the rear valley which is adequate at the present time although we cannot rule out the possibility that some further leaking may occur. If this is, indeed, the case then one would be prudent to consider relining of any dated valleys.

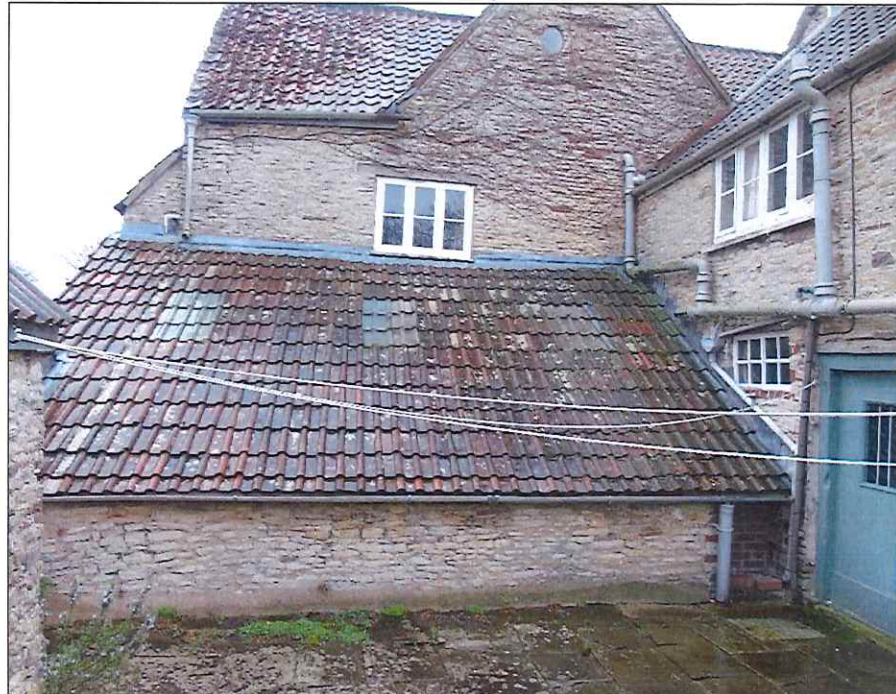
Single storey rear roof

The rear right hand single storey part of the building incorporating the “lower” kitchen has a mono pitched gable roof clad with clay double Roman tiles together with one or two glazed tiles. There was no indication of sag or deflection suggesting supporting timbers are of a suitable size to carry the imposed load upon them.

Tiles themselves appeared to be in reasonable condition with no major deterioration present.

Lead flashings have been incorporated at the joint between the upper tiles and the main part of the building. No obvious leaking was noted although there was slight lifting of the flashings which should be refixed.

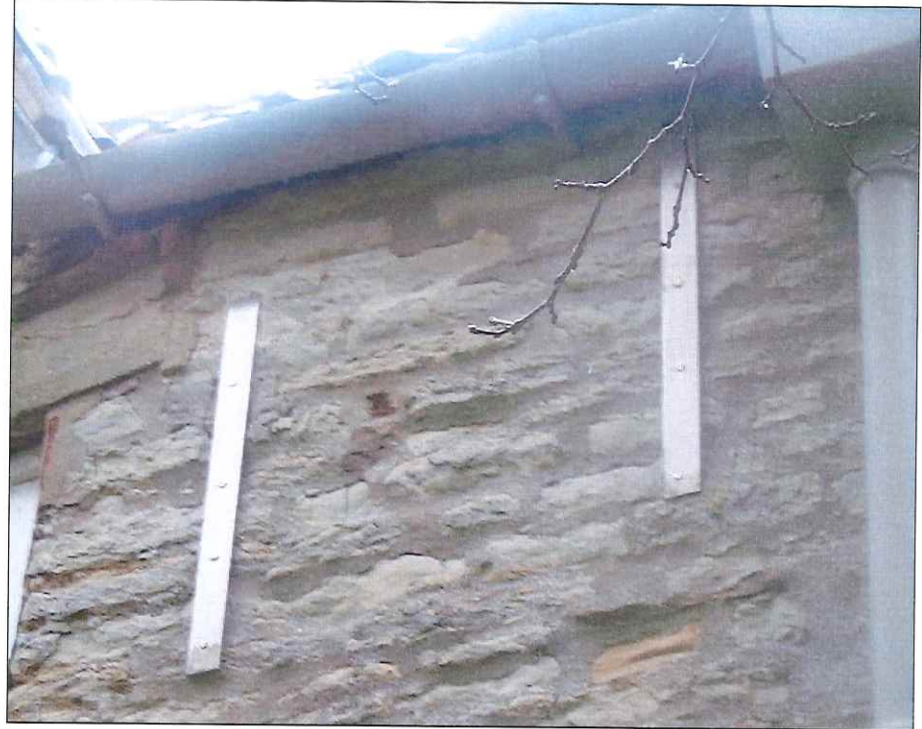
Tie bars – left hand flank wall

The property has been affected by fairly noticeable movement and distortion over the years visible both internally and externally. Internally, there is fairly noticeable deflection to floors together with distortion over door heads. There are also uneven walls, particularly to the left hand flank wall. Externally, there are noticeable distortions above/below window heads, particularly on the front and left hand side of the building and, to a lesser extent, other elevations. Some structural repairs have been carried out in more recent times including the addition of tie bars on the left hand flank wall and also further strengthening of roof timbers with modern metal brackets. Works of this type should ideally have been carried out under the supervision of a structural engineer and you would be prudent to obtain any information regarding this matter.

Action: Make provision for structural repairs, particularly in terms of renewing lintels. Consider further advice from a structural engineer in this respect.

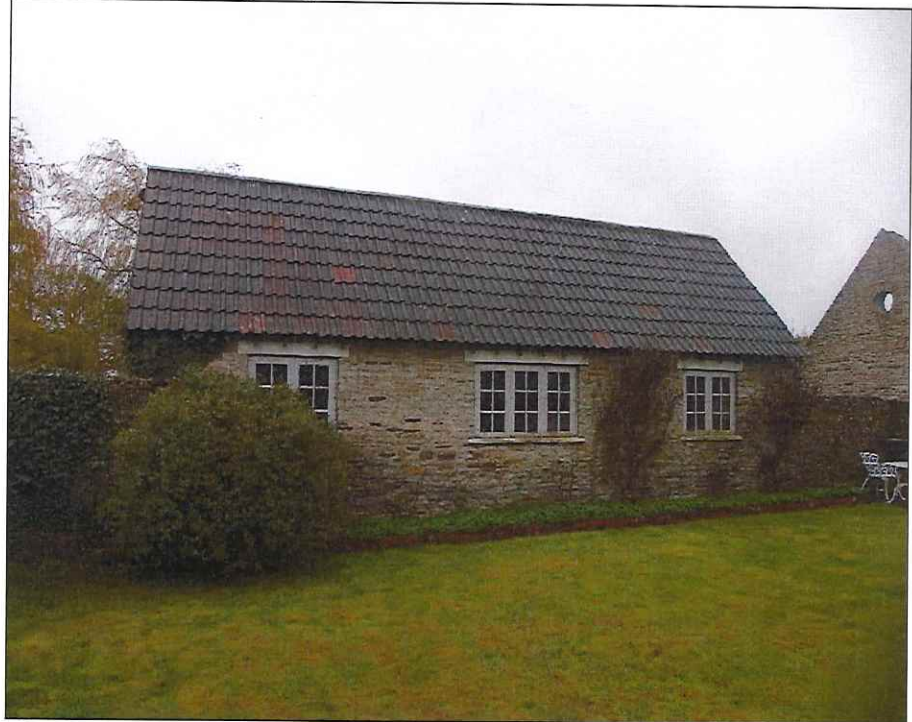
External view of garage

There is a garage on the left of the site which is of stone and brick construction under a gable pitched and tiled roof. The structure itself appeared to be reasonable although there are clearly a number of items of improvement and repair necessary to the garage itself.

Evidence of dampness is present which has allowed a number of bricks to perish internally and this should be attended to. You are advised not to store valuable or perishable items in this area without taking appropriate measures against damp.

Wood boring beetle infestation was noted to the internal timbers which should be treated by a specialist contractor.

The entrance door is damaged and requires rehangng. Certain areas of rot were identified to the frames which should be improved together with redecoration of any exterior joinery.

Some cracks were noted to the walls, particularly the front and side sections which will require stitching together with repointing.

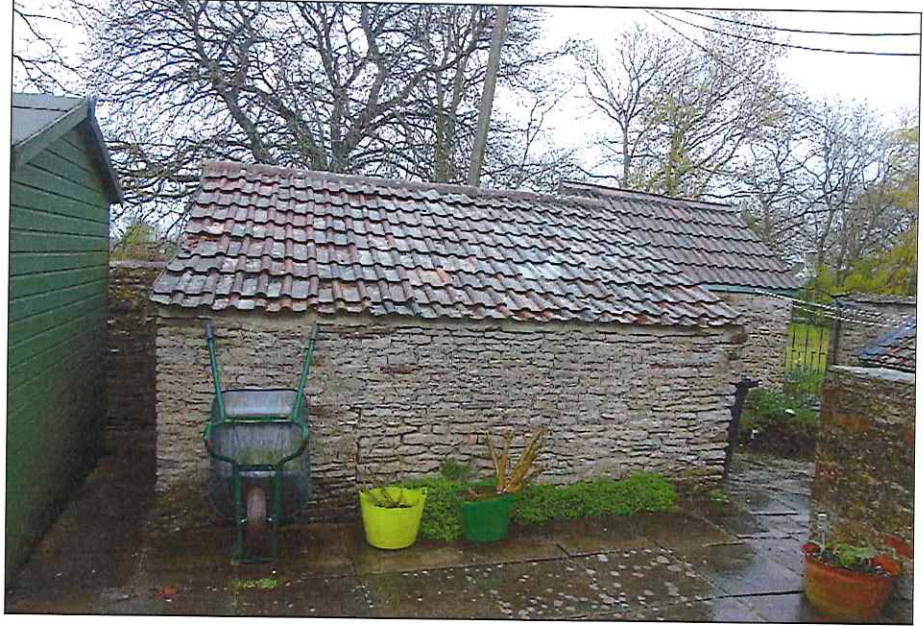
Oil/coal store

There is an oil tank/coal store in the rear garden which is of stone and timber construction under a pitched and tiled roof. These outbuildings are in rather poor condition and will require overhaul. The roof is clearly leaking due to a number of damaged tiles and the lack of felt underlining below. Rot was also noted to some exterior timbers together with wood boring beetle infestation to internal timbers.

There are no rainwater goods and new fittings should be appropriately fitted. In addition, cracking internally should be attended to in terms of stitching and filling as necessary.

The oil tank is located in one of the store areas and this is of metal construction. No obvious defects were noted during the survey.

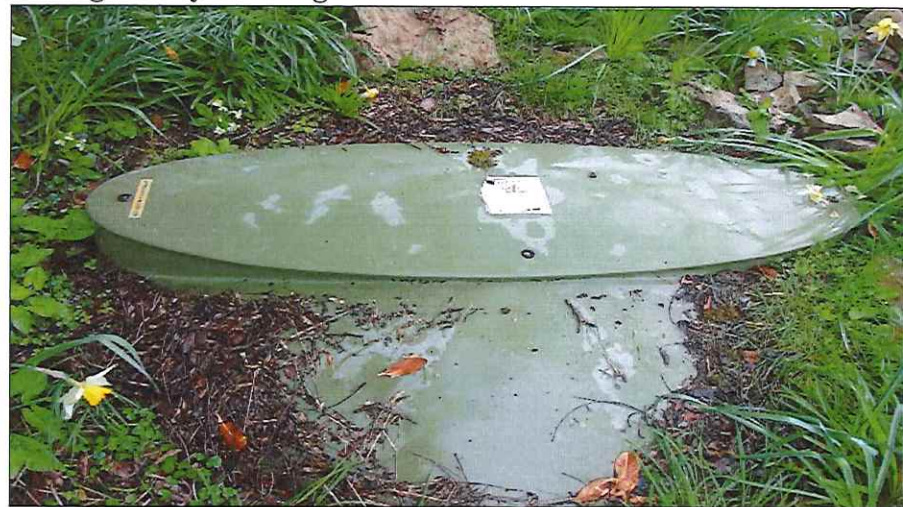
Bio digester system in garden

We understand that foul water drains to a biodigester which is positioned in the rear garden. All details appertaining to the installation of this machinery should be obtained and kept for future reference. You should also establish whether any recent works or clearing out have been undertaken.

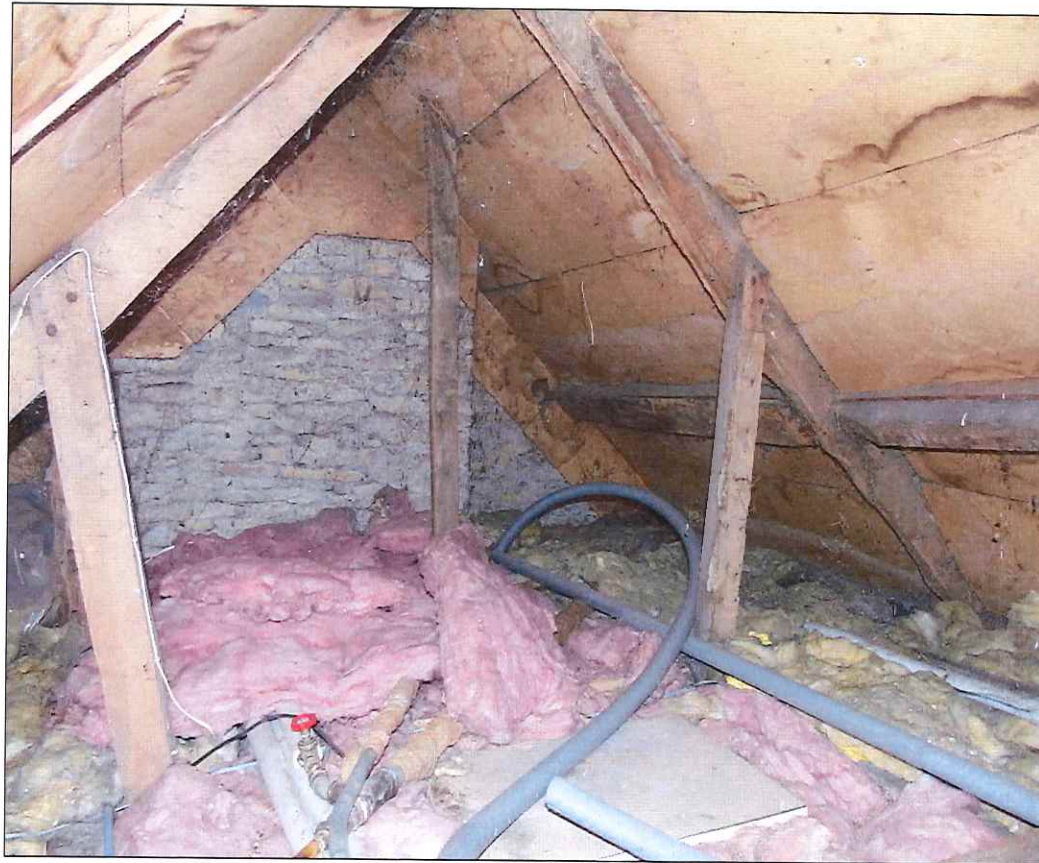
Rear roof void

Access was only possible to one roof void being at the rear of the building from a hatch on the upper staircase. A detailed examination was not possible bearing in mind timber boarding which has been incorporated below the timbers and no comment regarding supporting timbers or other materials can therefore be offered.

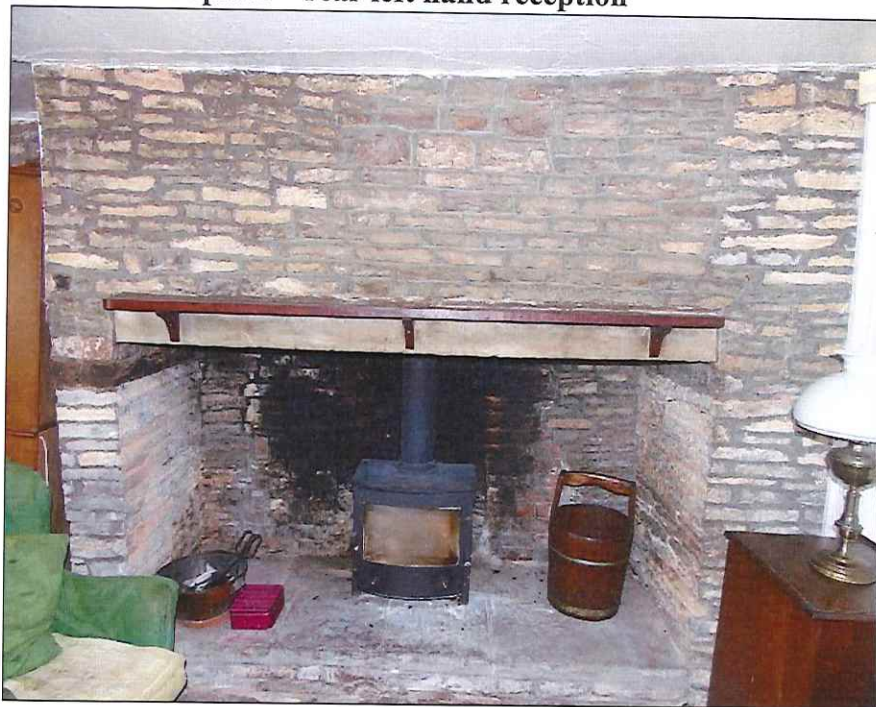
Attractive fireplace – rear left hand reception

There is an attractive stone surround incorporating a solid fuel burner within the rear left hand ground floor reception room. There is also an open fire in the left hand front ground floor room together with what appeared to be a coal fire in the right hand reception room. Fittings were not tested during the survey and we suggest that any built in items such as solid fuel burners be appropriately serviced in accordance with the manufacturers recommendations.

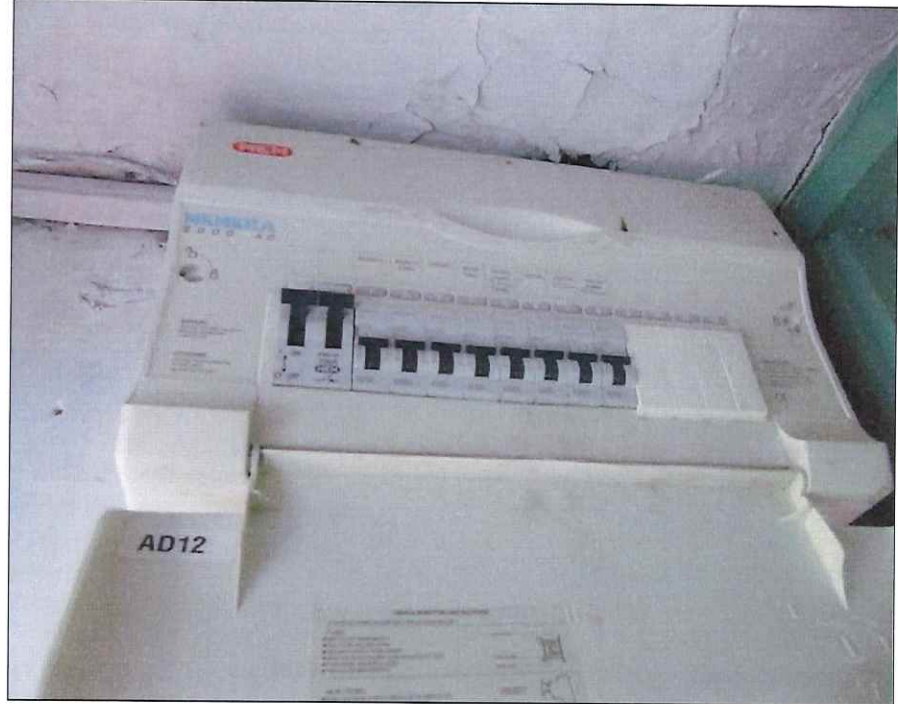
MCB's in rear lobby

The property is believed to be connected to the main electrical supply and we noted MCB's incorporated in the rear lobby. Nevertheless, certain aspects of the system are rather dated and poorly fitted including significant amounts of surface laid electric cable and rather randomly positioned plug outlets.
